**BLUE OAK ASSESSMENT  
DISC GOLF COURSE DESIGN REVIEW AND  
BLUE OAK MANAGEMENT GUIDELINES**

**Prepared for  
THE CITY OF CHICO**

**Prepared by  
TREE ASSOCIATES  
John M. Lichter, M.S.**

**November 18, 2005**

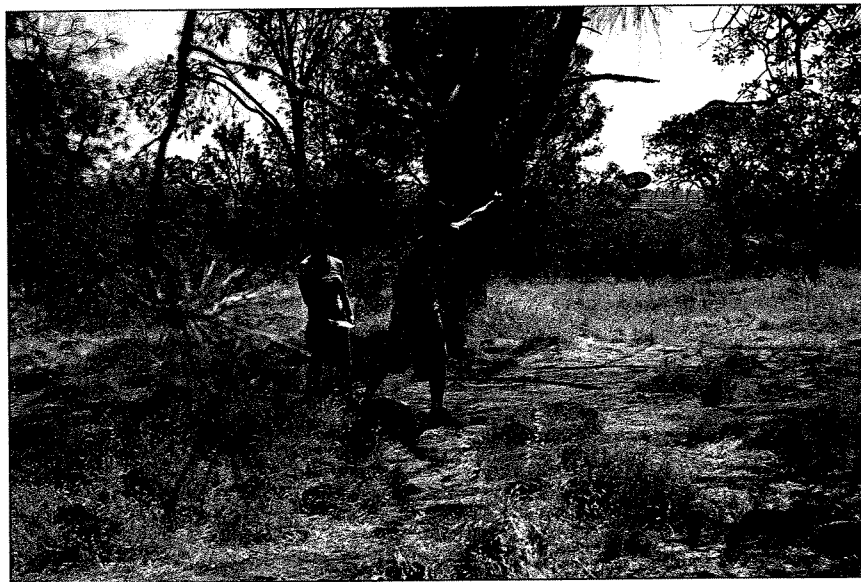
Figure 1. Disc golfers playing short course.

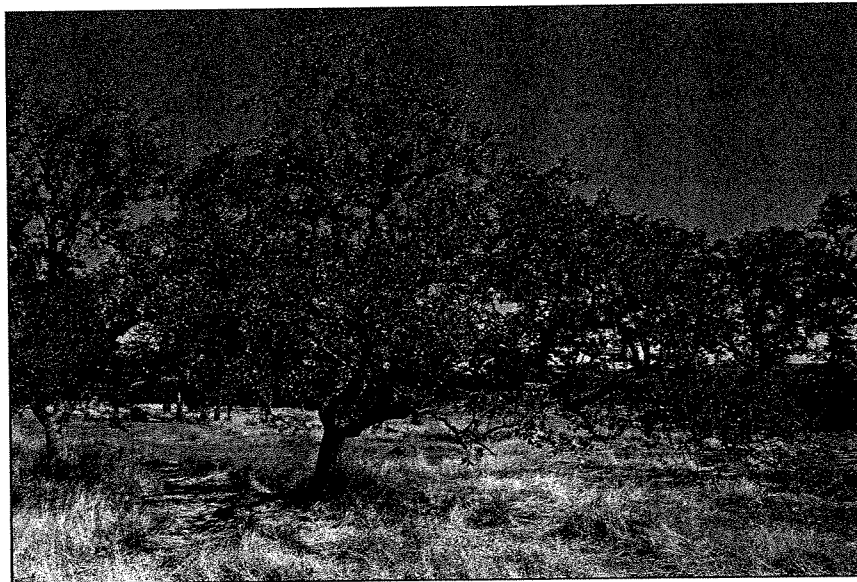
**Figure 2. Tree in fair/good health on short course.**

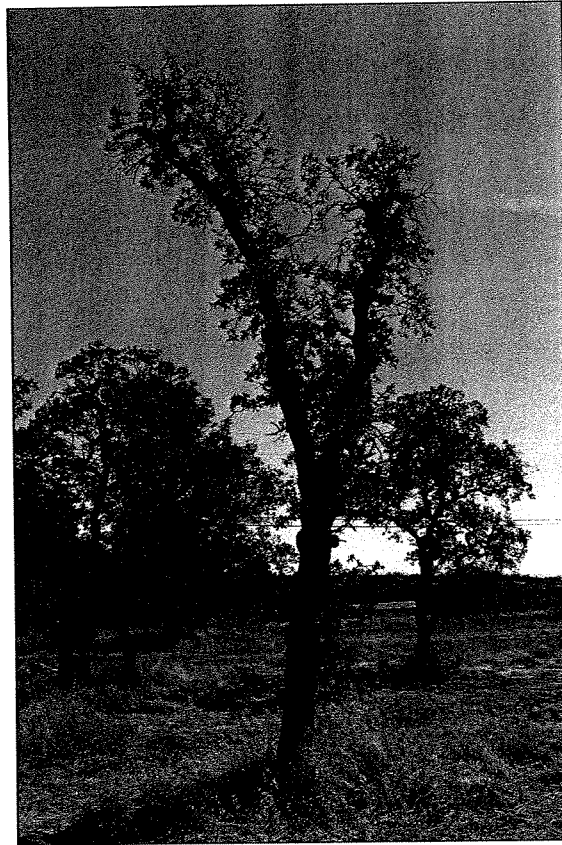
Figure 3. Tree in poor condition on short course; note poor growth rate and epicormic sprouts (low vigor twigs on main trunk).

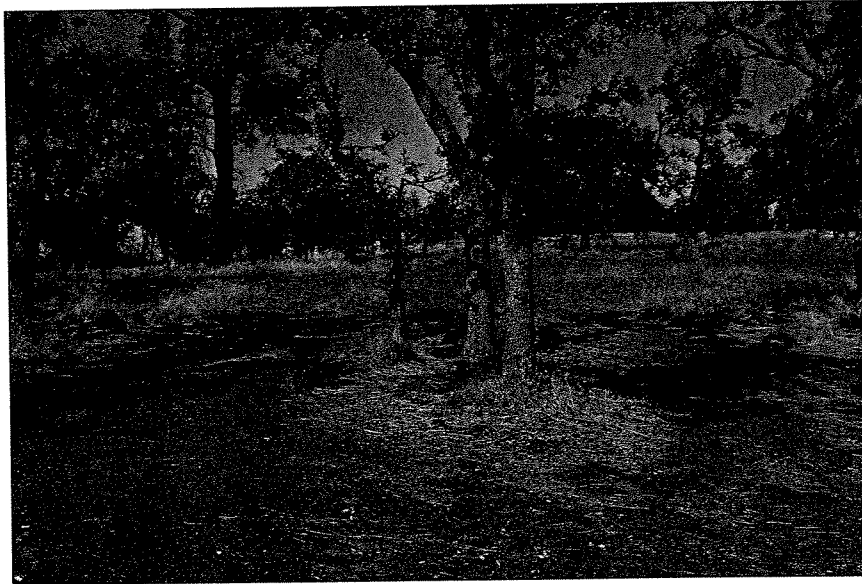
The loss of vegetation, organic matter and soil compaction was most pronounced at the tee and pin areas on both courses (figure 4). Within the short course, the fairways were heavily trampled throughout, while on the long course, only a few narrow trails were typically found on the fairways.

Soil compaction rearranges soil particles, increasing soil strength and reducing the amount of large pore space in the soil. These changes can restrict root growth directly, and lead to growth restriction and/or disease from their negative impact on soil water infiltration, drainage and aeration.

Figure 4. Soil disturbance under oaks on short course.

Breaking up the soil (i.e. tilling or subsoiling) when it is fairly dry is an effective means of ameliorating compacted soils (Harris, R., N. Matheny and J. Clark, 2004). However, "tree root sensitive" treatments for breaking up soils in the root zone of trees are limited. Soil removal and replacement (with sandy loam, organic matter or combinations of soil and organic matter) in radially-oriented trenches has been shown to increase tree growth (Day and Bassuk, 1994; Watson, Kelsey, and Woodtli, 1996; and Smiley, 1997). The soil can also be broken up effectively with minimal damage to tree root systems utilizing a pneumatic excavator. Recently, soil compaction amelioration treatments utilizing a pneumatic excavator to break up the soil while incorporating organic matter have been recommended by Smiley (personal communication).

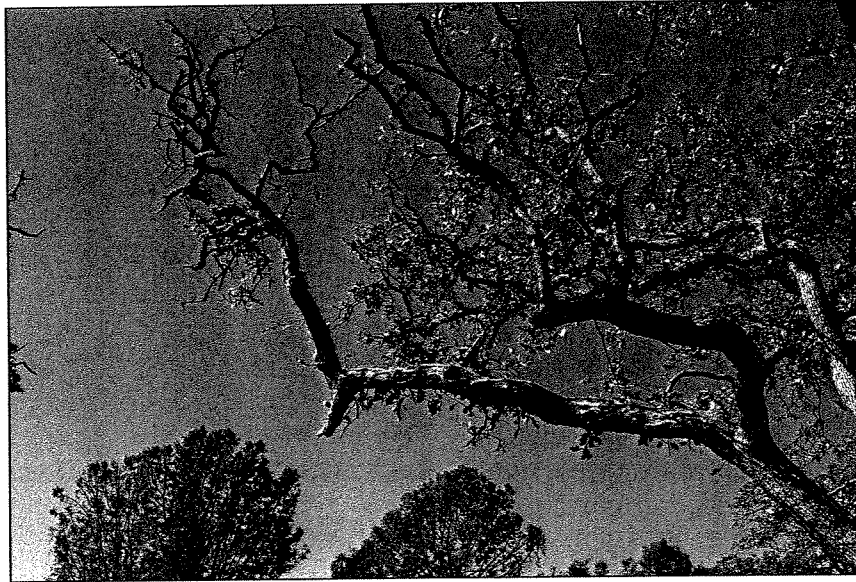
The loss of branch tips and foliage was widespread across the course, particularly where trees were in the middle of the fairway (figure 5). In several cases, greater than 50% of the foliage and branch tips had been removed by discs. The amount of foliage and branch tip loss was generally greater on the short course than for the long course.

Several trees across the course sustained significant damage to their cambium from disc contact; particularly trees close to tees (figure 5).

Figure 5. Loss of foliage and growing points and limb damage from disc impact on short course.

For such affected trees, wrapping the trunk or limbs with protective material or shielding the impacted (or potentially impacted) trunk or limbs will limit impacts. Trunk or limb wrapping should be done in such a way as to avoid girdling (restricting diameter growth) the tree. Shielding should be done in such a way as to avoid root injury.
