**Upper Bidwell Park Road
Sediment Source Assessment
and Treatment Action Plan,
Butte County, California**

PWA Report No. 171028801
May, 2017

City of Chico, Parks Division

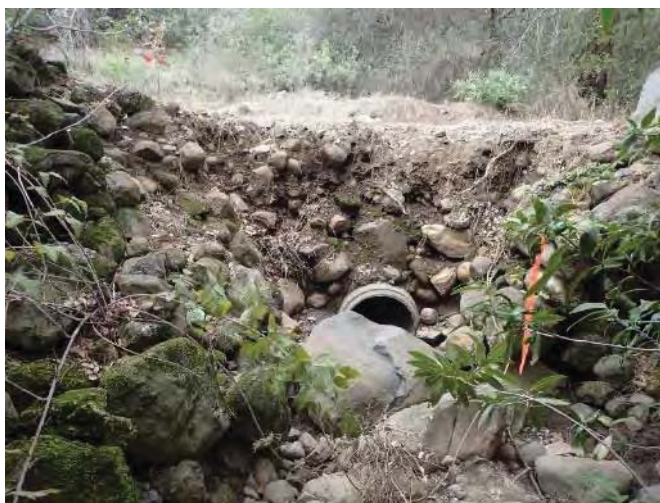
Of the 40 inventoried stream crossings, 35 have the potential to divert in the future and 7 of the streams are currently diverted out of their natural stream channels (Table 3). Of the existing 37 culverts at stream crossings, 27 (77%) are undersized and not sufficiently designed for the 100-yr peak storm discharge, and 15 are judged to have a high potential to become plugged by sediment and debris and (Table 3, Figure 1).

Figure 1. This stream crossing site is plugged by a boulder that dwarfs the concrete culvert inlet. The culvert is undersized for the upslope drainage area and was assigned a high priority for treatment.

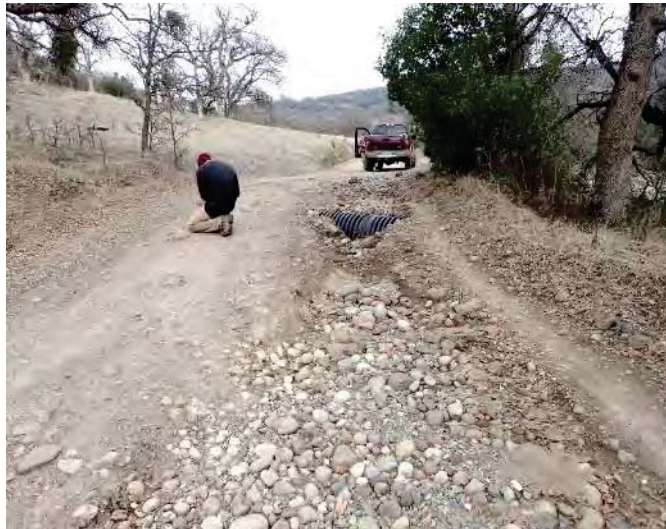
1. Feature #27 is a culverted stream crossing with a moderately-high treatment immediacy. This ephemeral stream has a properly sized plastic 24 inch diameter culvert, however, the culvert is set high in the fill and is exposed in the middle of the road surface. There is no road fill or driving surface over the exposed plastic culvert (Figure 2). In addition, a long length of uncontrolled road surface and ditch (620 linear ft) delivers concentrated surface runoff and eroded fine sediment to the inlet of the culvert at the stream crossing. The inboard ditch leading to the crossing from the left road approach is eroded and actively downcutting, which also delivers coarse sediment to the culvert inlet and stream. This crossing should be upgraded with an armored fill or properly placed culvert designed to pass the peak 100-year flow estimates. The road surface on the right hinge line should be dipped to prevent stream diversion. The left road approach should be treated with road outsloping (including berm removal) and rolling dips, or ditch relief culverts to prevent an estimated 118 yd³ of fine sediment from being delivered to the stream system at this location.

Figure 2. At feature #27 the stream crossing culvert is exposed by erosion cause by an active road surface gully.

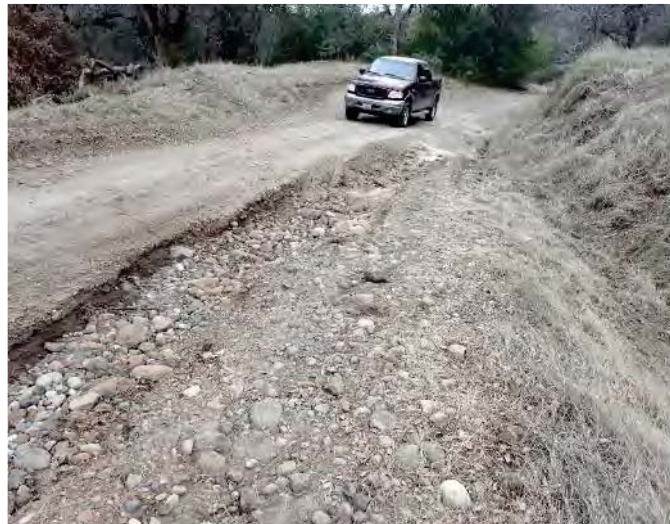
A long section of road between stream crossings #27 and #28 contains uncontrolled road surface runoff that collects and concentrates on the road bed and has created a deep and continuous gully down the center of the road (Figure 3). The road surface gully is relatively large and has downcut deeply into the road surface, exposing the top of the stream crossing culvert at feature #27 (Figure 2). The gully currently requires careful navigation to pass in a 4wd vehicle and is impassable by 2wd vehicles. The road surface leading to, and including, the gullied section will need to be upgraded by reshaping and construction of road drainage structures to disperse road surface runoff sufficient to prevent renewed gullying and to improve (disperse) long term road drainage.

Figure 3. Vehicular passage with a 2wd car is inhibited by this large gully down the center of Upper Park Road.

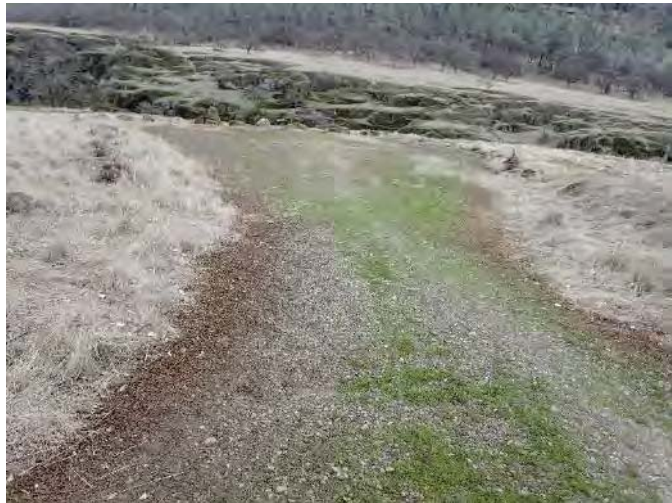
PWA evaluated the existing conditions of the visitor parking areas on the 4.40 mile segment of Upper Park Road. We identified, mapped and assessed 16 parking areas (Parking Areas "F" through "U") to determine if sediment control and erosion prevention treatments could be applied to protect or improve water quality. Our observations did not identify a single notable erosion feature that delivered sediment to the stream network. We found that the majority of parking areas were constructed directly upon bedrock, with minor surfacing, which is largely resistant to erosion and mechanical wear from vehicle traffic (Figure 4).

Figure 4. Each individual parking areas showed minimal signs of erosion or sediment delivery. It will important to reduce any potential run-on that may negatively affect these parking areas.

In general, PWA determined that preventing run-on from Upper Park Road is a key factor in erosion prevention of the parking areas. Maintaining Upper Park Road as an insloped road while near the parking areas on the outer edge of the road prevents run-on and consequent erosion. Continued maintenance of the overall area at these generally small-sized parking areas also reduces the area of disturbance which can help reduce the magnitude of parking area erosion. Utilizing large rocks around the perimeter of each parking area is a good method that is currently being used to control off-area vehicle use and it serves to minimize the area of disturbance.

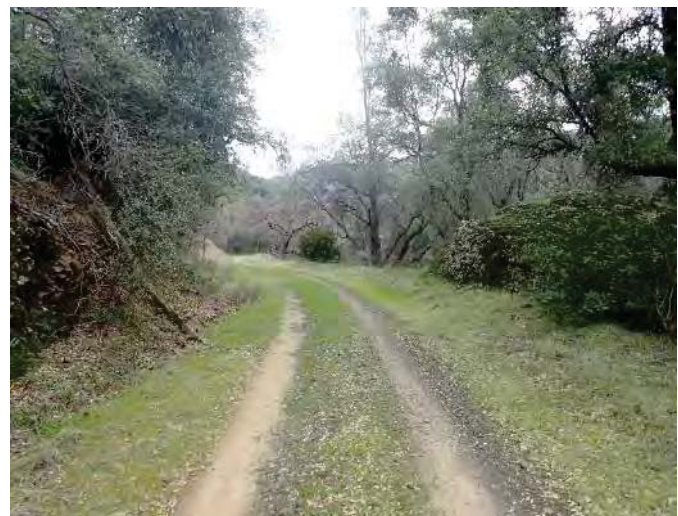
In December 2012, a severe storm damaged several sections of Upper Park Road. While the Parks Division was later able to re-grade and add road surfacing (base rock) along a section of the road to the Diversion Dam parking Area “L” located at milepost 1.77 to allow access for seasonal vehicular traffic, staff kept the section beyond the Diversion Dam closed because of the narrowed width and steep grade of the road, potential road wear, past roadway erosion and gullying, and lack of road base.

Figure 5. The bare surface area on the road is reduced beyond the gate located at the Diversion Dam Parking Area. Reduced levels of vehicular use can allow vegetation to cover the road and reduce the intensity and magnitude of road-related runoff, erosion and sediment delivery.

Trails Plan, and suggest closure to unrestricted vehicular users at the Diversion Dam Gate policy be implemented year round, while access for patrol vehicles, emergency fire and medial use remain year-round.

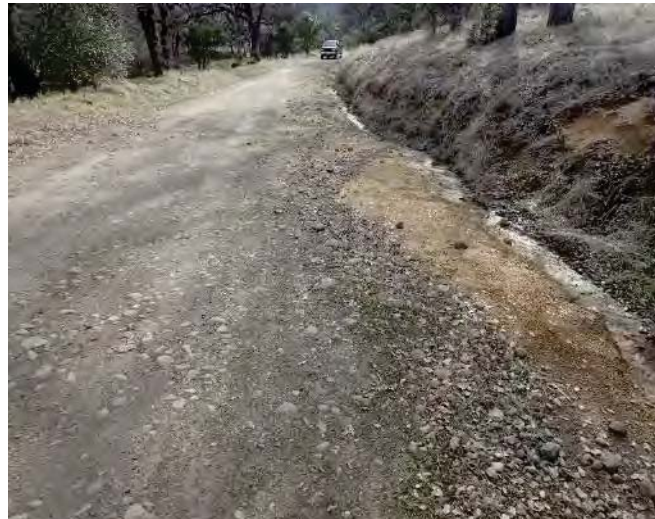
Wherever a hydrologic connection exists, road surface runoff and fine sediment is delivered to streams every time there is a rainfall event sufficient to produce surface runoff and cause erosion of bare soil areas. Concentrated runoff on compacted surfaces and ditches results in erosion and road-related sediment transport to nearby streams. The most common road-related bare surface areas include unpaved road surfaces, as well as bare (unvegetated) fillslopes, cutbanks, ditches, and landslide surfaces. PWA identified and mapped 78% of Upper Park Road (3.42 miles) as being hydrologically connected to stream channels (Figure 6).

Figure 6. Road surfaces, berms and ditches capture and transport hillslope runoff and direct rainfall during storms. Road surface and ditch runoff often flow down the road grade and directly into stream crossing culvert inlets.

The road surface treatments PWA has recommended are designed to control, direct and disperse road surface runoff and ditch flow onto adjacent hillslopes by reshaping the roadbed and constructing road drainage structures. These techniques act to disperse road surface runoff and reduce or prevent delivery of concentrated road runoff and fine sediment to streams (Weaver et al., 2015). At total of 3.42 miles of road surface upgrading treatments are designed to redirect surface runoff, recommendations include outsloping, insloping, berm removal, and installing rolling dips and ditch relief culverts to more frequently discharge runoff along Upper Park Road. Upgrading treatments also include locally realigning or rerouting 4 short sections of the road that are poorly located and infeasible to effectively drain and stabilize (Table 5). For each recommended road surface drainage treatment where ground disturbance will occur we estimated the volume and trucking cost to apply road rock surfacing, which curtails road surface erosion by fortifying the road surface and reducing the rate of downwearing, surface erosion, and fine sediment production and delivery; a total of nearly 3,100 yd³ of base rock will be used to treat the road surface where road upgrading (reshaping and/or drainage structure construction) is recommended.

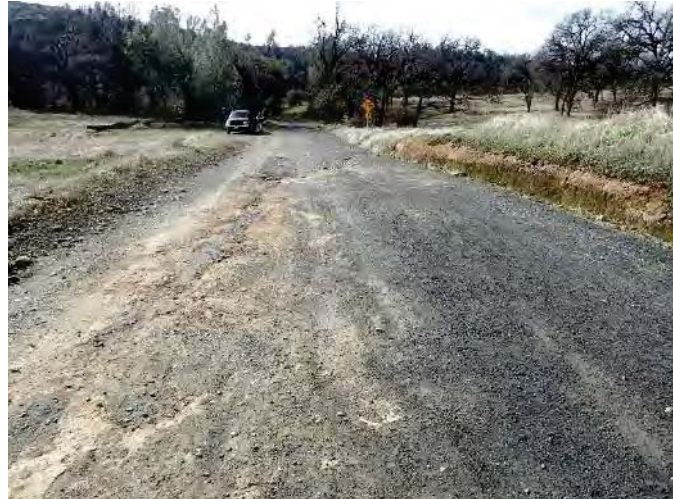
Figure 7. Roads that are flat in cross section, with an outside berm and inside ditch, intercept do not allow the runoff to leave the road. Concentrated road surface and ditch runoff flows down the road with increasing velocity and discharge, creating surface erosion, rills and gullying.

recommended for road outsloping (Figure 7). Each segment of outsloped road will have the outside berm removed and will be resurfaced with road rock. An outsloped road cross section is likely to capture and disperse road surface runoff. It has less environmental impact and lower maintenance costs than other designs. Outsloping high priority road segments of Upper Park Road will minimize flow volumes and the magnitude of runoff in the inside ditch, as well as reduce the potential for erosion, hydrologic connectivity and sediment delivery from the road surface. An outsloped road ensures that turbid road runoff and fine sediment eroded from the roadbed will be quickly drained to the outside edge of the road where it can be safely discharged onto vegetation and into undisturbed slopes (see Appendix C for typical design drawings).

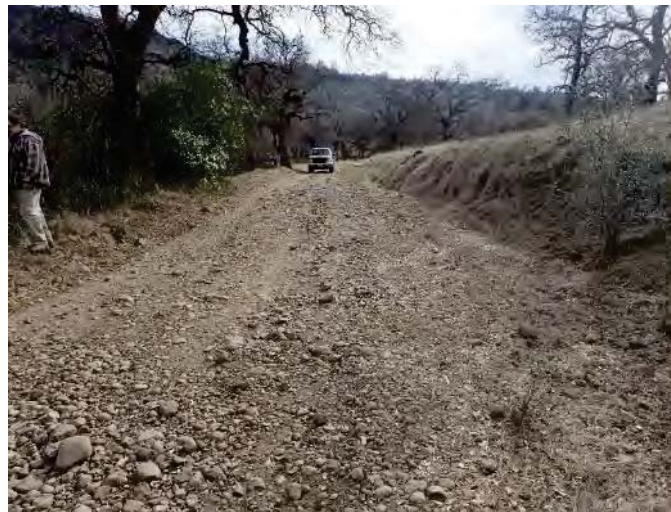
Upper Park Road is slightly “through-cut” (trench-like with berms or cuts on both sides) and flat in cross section. As a result, the road exhibits poor road drainage and actively eroding ditches. Steep road segments beyond the Diversion Dam experience the highest rates of wear. Road outsloping and road surface drainage structures are needed to lessen the flow volumes in the ditch and further disperse surface runoff. As is common on many unpaved roads here and elsewhere, routine road surface maintenance (smoothing) activities are contributing to the slightly through-cut road and berm development; it is a common result of annual maintenance grading and consequent gradual lowering of the road surface (Figure 8). Poor road surface drainage will not improve until the road berm is removed or the road is outsloped, raised and crowned, or paved.

Figure 8. On Upper Park Road a berm has formed after years of grading and road surface erosion. The berm captures and concentrates road runoff, preventing it from being dispersed onto the hillside, and accelerates road surface and ditch erosion rates.

Serious damage to the road structure and road surfaces have been identified with the loss of road drainage, erosion of road surfacing materials and excess standing water on the surface. Ruts and mud indicate that road strength is deteriorating (Weaver et al., 2015). This bermed and through-cut road has locally led to the development of rills and gullies where the road is steep, and to potholes and mud puddles where it is gentle. Outside berms created by maintenance grading have unintentionally concentrated road runoff during winter storms and need to be removed from the outside edge of the road wherever they are preventing proper road drainage.
