**REPORT
OF
INITIAL SITE ASSESSMENT
ESPLANADE CORRIDOR SAFETY AND ACCESSIBILITY IMPROVEMENT
PROJECT
CHICO, CALIFORNIA
CAPITAL IMPROVEMENT PROJECT NO. 50355;
FEDERAL PROJECT NO. ATPCML-5037(037)**

Subject: Initial Site Assessment
Esplanade Corridor Safety and Accessibility Improvement Project
Capital Improvement Project NO. 50355; Federal Project No. ATPCML-5037(037)
Chico, CA 95669
Burleson Project Number 3900

EXECUTIVE SUMMARY
Initial Site Assessment
Esplanade Corridor Safety and Accessibility Improvement Project
Chico, California

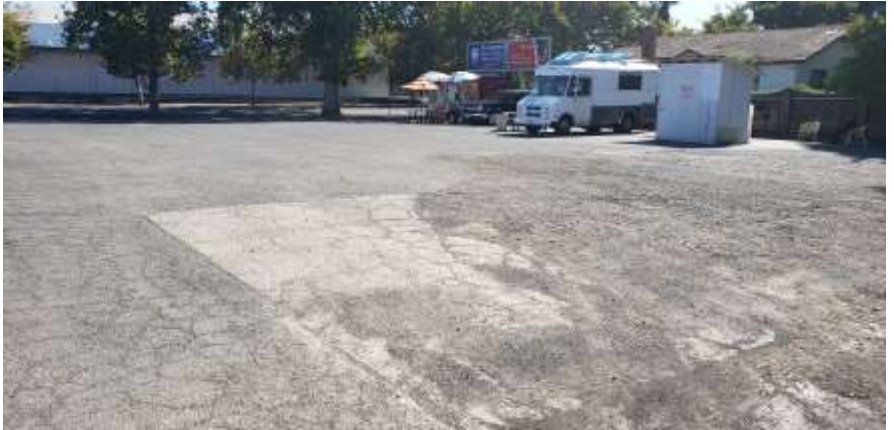
- Cash Oil, located at 111 W 11th Avenue: Former gas station containing a parked food truck, trash can, storage shed, and stormwater drain with dark stains (possible oil) near a drainage inlet at Esplanade (Appendix B; Photograph 1). EDR results show the property had a leaking underground storage tank;

- The Cash Oil property located at 111 W 11th Avenue is within the project area. The site is primarily a vacant paved lot utilized by mobile food vehicles and contains a storage shed structure. The site contained a leaking gasoline tank that received remedial efforts and the case was closed. Due to historic and current evidence, proximity to construction activity, and the level of ground-disturbing activity anticipated as part of the project in this vicinity (3-inch depth), Burleson has identified the site as a **low-risk HREC**.

Viewing Direction ↑=NORTH	Photo Description	Photo
↘	1. View of the historic Cash Oil site showing a change in pavement type, food vehicle, and storage structure.

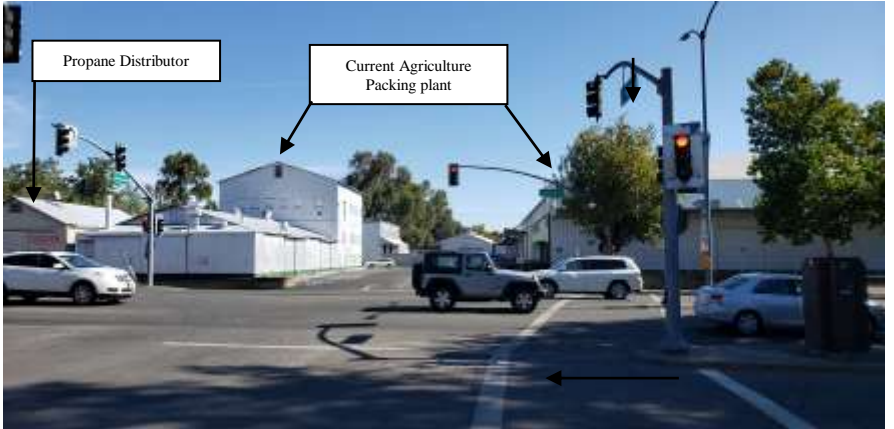
- Vanella Oil Inc. Bulk Plant located at 2140 Esplanade, at East 11th and Esplanade is a site containing three large industrial buildings and occurs adjacent to the project area. Historic aerial imagery indicate that the site has been active since the 1940s. The site is currently being utilized by an agricultural packing facility and propane distribution facility. The site contains petroleum storage tanks with an extensive regulatory record of compliance violations but no contamination or remedial activity documented. Due to historic and current evidence, proximity to construction activity, and the level of ground-disturbing activity anticipated as part of the project in this vicinity (3-inch depth), Burleson has identified the site as a **low-risk REC**.

→	2. View of the Vanella Oil Inc. Bulk Plant site. Image showing agriculture industrial and propane distribution facilities.

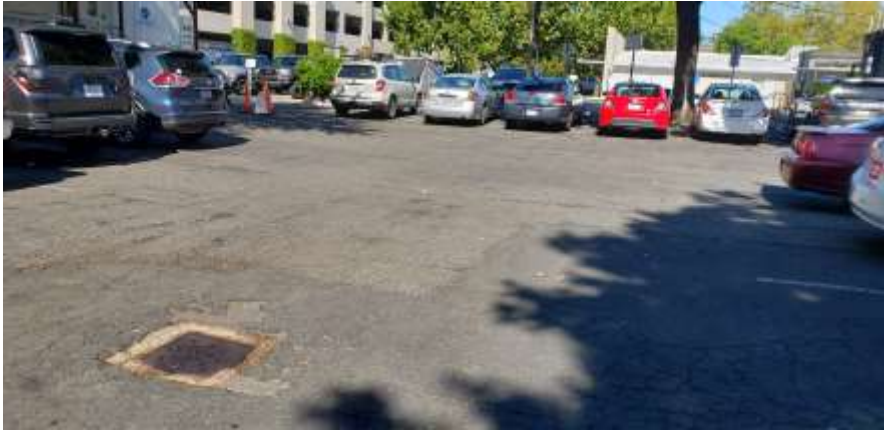
- Enloe Hospital Property, located at 120 W 6th Avenue: Property is currently a medical center containing several businesses. Site contained a heating, ventilation, and air conditions system and a stormwater drain in the parking lot (Appendix B; Photograph 3). EDR results indicate a diesel LUST (case closed);

- Enloe Hospital property is an active medical business center located at 120 W 6th Avenue adjacent to the project area. The site contained a leaking diesel tank. that received remedial efforts and the case was closed in 2010. Due to historic evidence, proximity to construction activity, and the level of ground-disturbing activity anticipated as part of the project in this vicinity (3-inch depth), Burleson has identified the site as a **low-risk HREC**.

<p>3. View of the Enloe Hospital site showing the stormwater drain inlet located at the facility parking lot.</p>

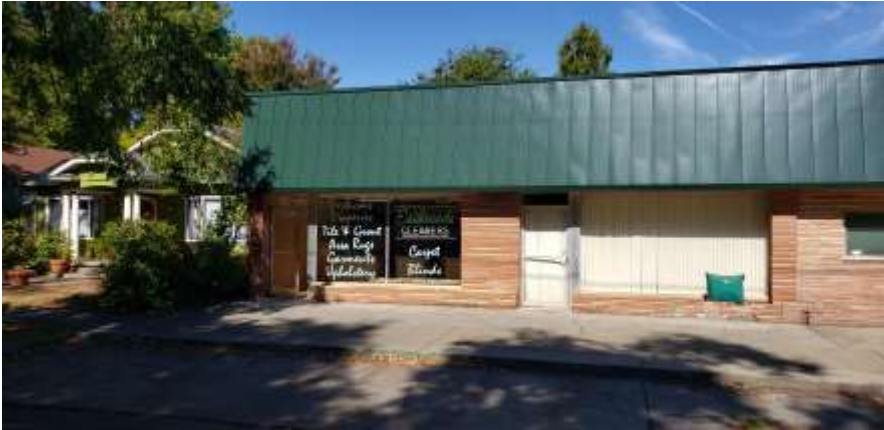
- Esplanade Cleaners located at 164 East 2nd Avenue, between the Esplanade and Oleander Avenue corridors is an active dry cleaner adjacent to the project area. The site has an extensive regulatory record of compliance violations, remedial activity, and has been identified as a PCE source contributor to the Central Chico groundwater plume that extends beneath the project corridor. Site reconnaissance observed a monitoring well in front of the facility within the paved section of E 2nd Avenue. Due to historic and current evidence, distance from the anticipated construction activity, and the level of ground disturbing activity anticipated in the vicinity (3-inch depth), Burleson has identified the site as a **low-risk REC**.

<p>4. View of the Esplanade Cleaners site showing the front of the building that indicates that business is currently active.</p>

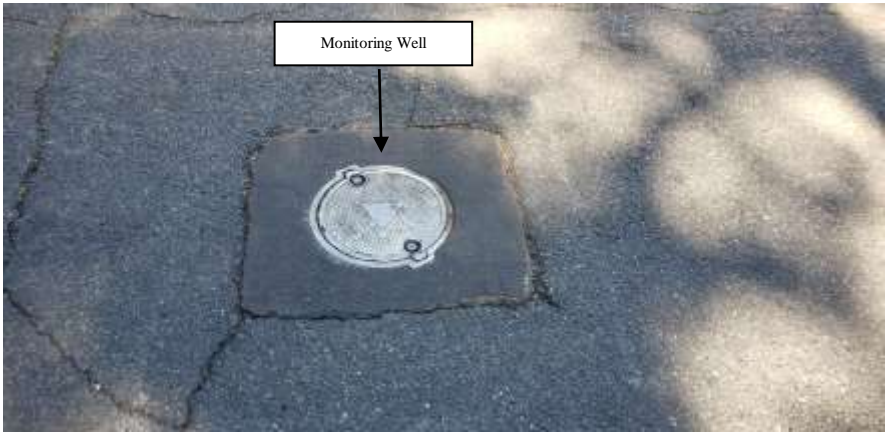
- Esplanade Cleaners, located at 164 East 2nd Avenue: Property is an active dry-cleaning facility. Site contained a potential polychlorinated biphenyls electrical transformer, marked monitoring well, and roof-mounted swamp cooler (Appendix B; Photographs 4 and 5). EDR results show the property is part of an active remedial investigation. The owner was found to be disposing PCE into the sewer system. The facility has been identified as a source of groundwater contamination in the Central plume;

<p>5. View of the Esplanade Cleaners potential monitoring well location. The well is located on 2nd Avenue in front of the facility.</p>

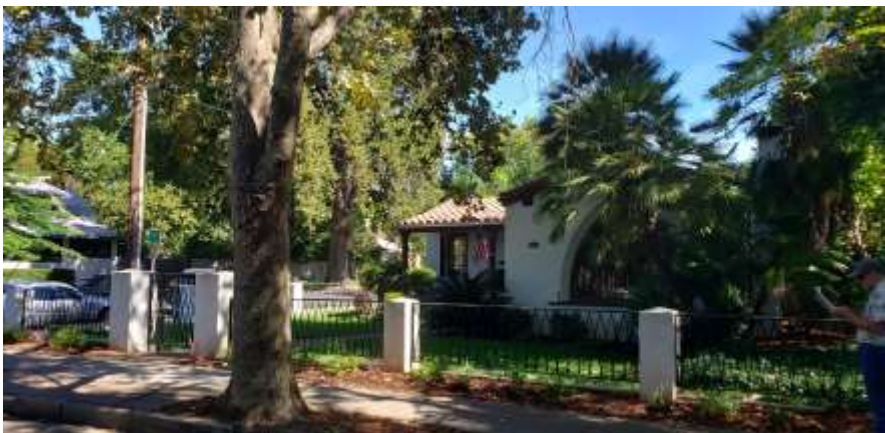
- Nichols Family Trust, located at 750 Esplanade: Property is currently a private residence. Site contained a potential polychlorinated biphenyls electrical transformer and no evidence of underground storage tank was observed (Appendix B; Photograph 6). EDR results show the property contained a 500-gallon gasoline storage tank;

- Nichols Family Trust, located at 750 Esplanade, at the corner of Esplanade and Lincoln Avenue is a residential property adjacent to the project area. A 500-gallon gasoline storage tank was reported at this site. Regulatory records indicate no compliance violations have occurred, leaks reported, or activity or condition status. No evidence of a tank or remedial activity was observed during site reconnaissance inspections. Due to historic and current evidence, proximity to construction activity, and the level of ground disturbing activity anticipated as part of the project in this vicinity (3-inch depth), Burleson has identified the site as a **low-risk REC**;

<p>6. View of the Nichols Family Trust Site. The photograph shows that the location is currently an active residential property.</p>

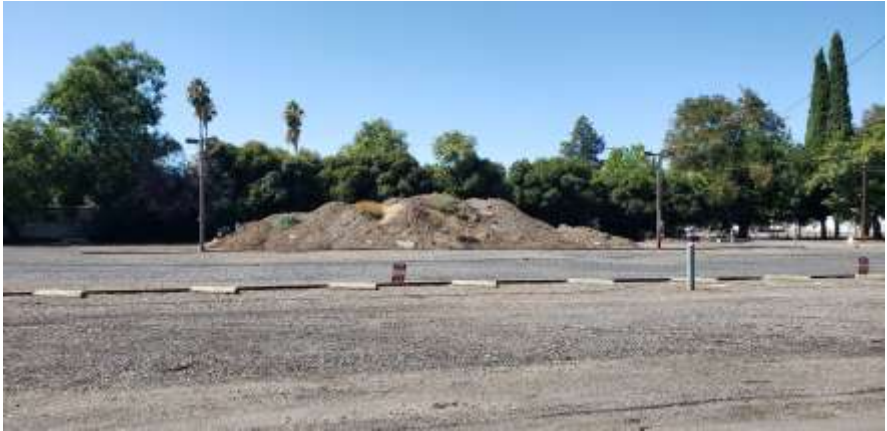
- Parking lot near the Vanella Oil Inc. Bulk Plant site, located at the intersection of Oleander Avenue and 10th Street: Property appeared to be previously associated with the current agricultural packing facility. Currently, the property is roped off with no trespassing signs and a large soil stockpile in the northwest corner of the property (Appendix B; Photograph 7); and
- Chico Area Groundwater Plume-Central Plume: No visual evidence for the groundwater plume was observed.

<p>7. View of the vacant parking lot near the Vanella Oil Inc. Bulk Plant site. The photograph shows the large soil stockpile.</p>
