**Upper Bidwell Park Road
Sediment Source Assessment
and Treatment Action Plan,
Butte County, California**

PWA Report No. 171028801
May, 2017

City of Chico, Parks Division

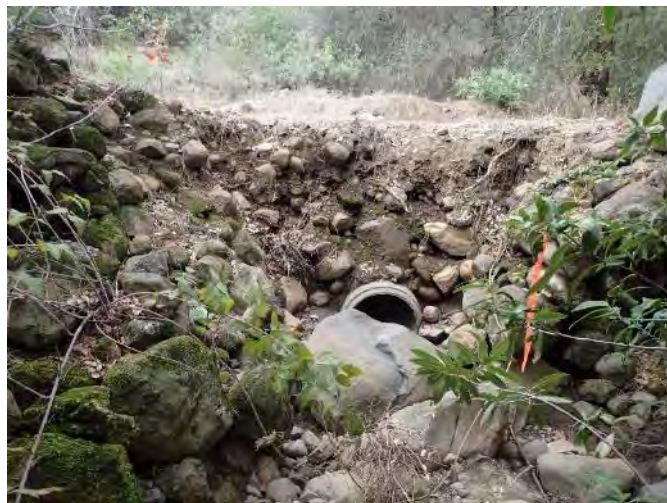
Of the 40 inventoried stream crossings, 35 have the potential to divert in the future and 7 of the streams are currently diverted out of their natural stream channels (Table 3). Of the existing 37 culverts at stream crossings, 27 (77%) are undersized and not sufficiently designed for the 100-yr peak storm discharge, and 15 are judged to have a high potential to become plugged by sediment and debris and (Table 3, Figure 1).

Figure 1. This stream crossing site is plugged by a boulder that dwarfs the concrete culvert inlet. The culvert is undersized for the upslope drainage area and was assigned a high priority for treatment.

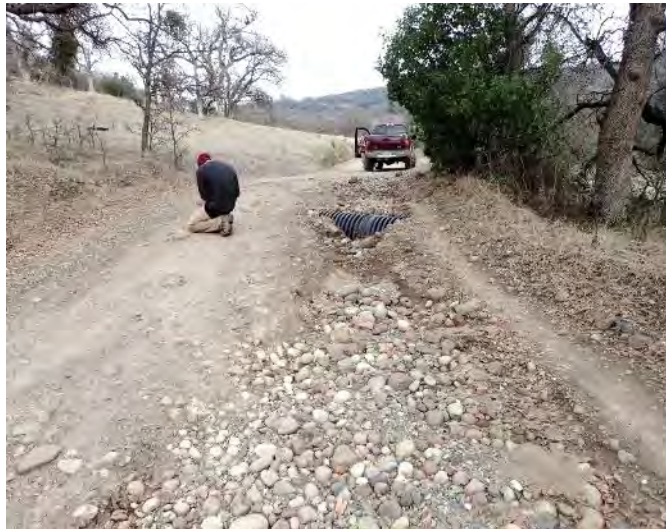
1. Feature #27 is a culverted stream crossing with a moderately-high treatment immediacy. This ephemeral stream has a properly sized plastic 24 inch diameter culvert, however, the culvert is set high in the fill and is exposed in the middle of the road surface (Figure 2). In addition, a long length of uncontrolled road surface and ditch (620 linear ft) delivers concentrated surface runoff and eroded fine sediment to the inlet of the culvert at the stream crossing. The inboard ditch leading to the crossing from the left road approach is eroded and actively downcutting, which also delivers coarse sediment to the culvert inlet and stream. This crossing should be upgraded with an armored fill or properly placed culvert designed to pass the peak 100-year flow estimates. The road surface on the right hinge line should be dipped to prevent stream diversion. The left road approach should be treated with road outsloping (including berm removal) and rolling dips, or ditch relief culverts to prevent an estimated 118 yd³ of fine sediment from being delivered to the stream system at this location.

Figure 2. At feature #27 the stream crossing culvert is exposed by erosion cause by an active road surface gully.

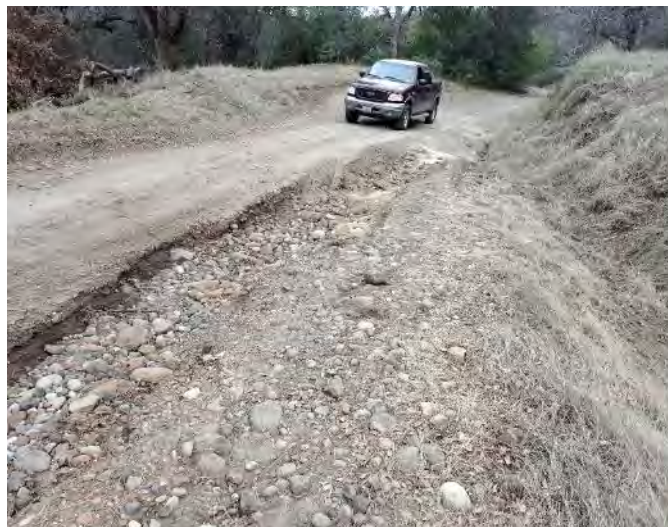
A long section of road between stream crossings #27 and #28 contains uncontrolled road surface runoff that collects and concentrates on the road bed and has created a deep and continuous gully down the center of the road (Figure 3). The road surface gully is relatively large and has downcut deeply into the road surface, exposing the top of the stream crossing culvert at feature #27 (Figure 2). The gully currently requires careful navigation to pass in a 4wd vehicle and is impassable by 2wd vehicles. The road surface leading to, and including, the gullied section will need to be upgraded by reshaping and construction of road drainage structures to disperse road surface runoff sufficient to prevent renewed gullying and to improve (disperse) long term road drainage.

Figure 3. Vehicular passage with a 2wd car is inhibited by this large gully down the center of Upper Park Road.

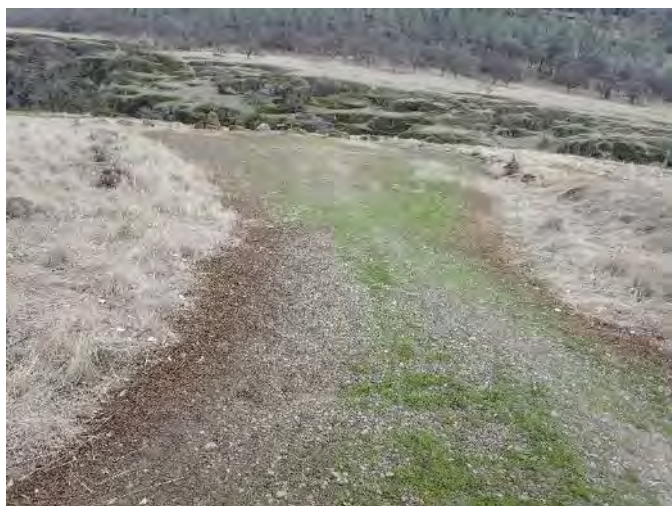
PWA evaluated the existing conditions of the visitor parking areas on the 4.40 mile segment of Upper Park Road. We identified, mapped and assessed 16 parking areas (Parking Areas “F” through “U”) to determine if sediment control and erosion prevention treatments could be applied to protect or improve water quality. Our observations did not identify a single notable erosion feature that delivered sediment to the stream network. We found that the majority of parking areas were constructed directly upon bedrock, with minor surfacing, which is largely resistant to erosion and mechanical wear from vehicle traffic (Figure 4).

Figure 4. Each individual parking areas showed minimal signs of erosion or sediment delivery. It will important to reduce any potential run-on that may negatively affect these parking areas.

In general, PWA determined that preventing run-on from Upper Park Road is a key factor in erosion prevention of the parking areas. Maintaining Upper Park Road as an insloped road while near the parking areas on the outer edge of the road prevents run-on and consequent erosion. Continued maintenance of the overall area at these generally small-sized parking areas also reduces the area of disturbance which can help reduce the magnitude of parking area erosion. Utilizing large rocks around the perimeter of each parking area is a good method that is currently being used to control off-area vehicle use and it serves to minimize the area of disturbance.

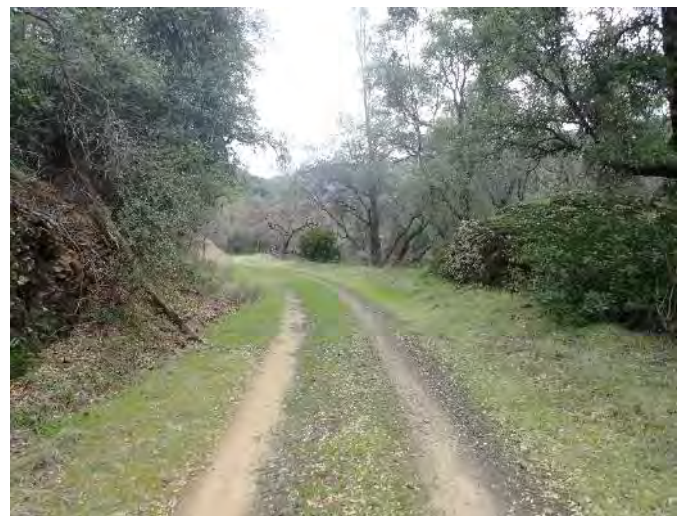
Figure 5. The bare surface area on the road is reduced beyond the gate located at the Diversion Dam Parking Area. Reduced levels of vehicular use can allow vegetation to cover the road and reduce the intensity and magnitude of road-related runoff, erosion and sediment delivery.

Trails Plan, and suggest closure to unrestricted vehicular users at the Diversion Dam Gate policy be implemented year round, while access for patrol vehicles, emergency fire and medial use remain year-round.

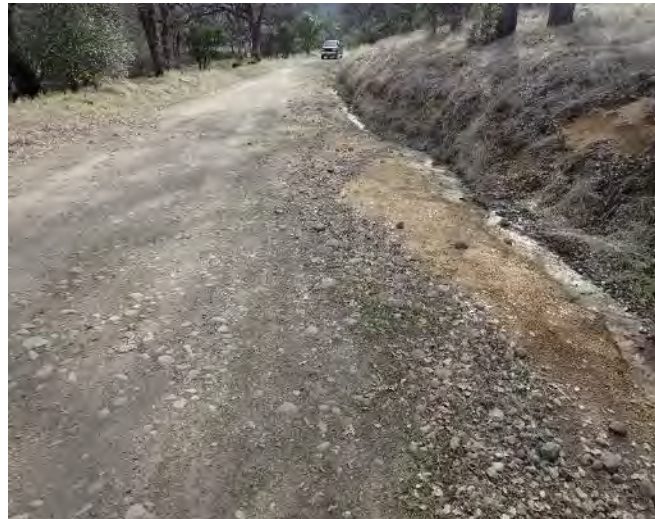
Wherever a hydrologic connection exists, road surface runoff and fine sediment is delivered to streams every time there is a rainfall event sufficient to produce surface runoff and cause erosion of bare soil areas. Concentrated runoff on compacted surfaces and ditches results in erosion and road-related sediment transport to nearby streams. The most common road-related bare surface areas include unpaved road surfaces, as well as bare (unvegetated) fillslopes, cutbanks, ditches, and landslide surfaces. PWA identified and mapped 78% of Upper Park Road (3.42 miles) as being hydrologically connected to stream channels (Figure 6).

Figure 6. Road surfaces, berms and ditches capture and transport hillslope runoff and direct rainfall during storms. Road surface and ditch runoff often flow down the road grade and directly into stream crossing culvert inlets.

The road surface treatments PWA has recommended are designed to control, direct and disperse road surface runoff and ditch flow onto adjacent hillslopes by reshaping the roadbed and constructing road drainage structures. These techniques act to disperse road surface runoff and reduce or prevent delivery of concentrated road runoff and fine sediment to streams (Weaver et al., 2015). At total of 3.42 miles of road surface upgrading treatments are designed to redirect surface runoff, recommendations include outsloping, insloping, berm removal, and installing rolling dips and ditch relief culverts to more frequently discharge runoff along Upper Park Road. Upgrading treatments also include locally realigning or rerouting 4 short sections of the road that are poorly located and infeasible to effectively drain and stabilize (Table 5). For each recommended road surface drainage treatment where ground disturbance will occur we estimated the volume and trucking cost to apply road rock surfacing, which curtails road surface erosion by fortifying the road surface and reducing the rate of downwearing, surface erosion, and fine sediment production and delivery; a total of nearly 3,100 yd³ of base rock will be used to treat the road surface where road upgrading (reshaping and/or drainage structure construction) is recommended.

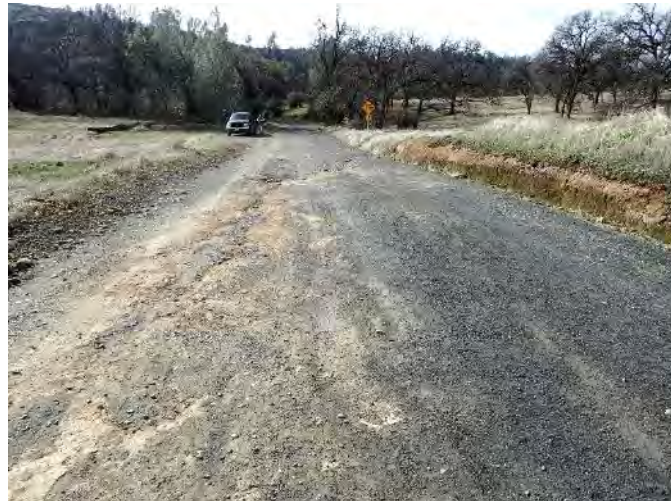
Figure 7. Roads that are flat in cross section, with an outside berm and inside ditch, intercept do not allow the runoff to leave the road. Concentrated road surface and ditch runoff flows down the road with increasing velocity and discharge, creating surface erosion, rills and gullying.

An outsloped road ensures that turbid road runoff and fine sediment eroded from the roadbed will be quickly drained to the outside edge of the road where it can be safely discharged onto vegetation and into undisturbed slopes (see Appendix C for typical design drawings).

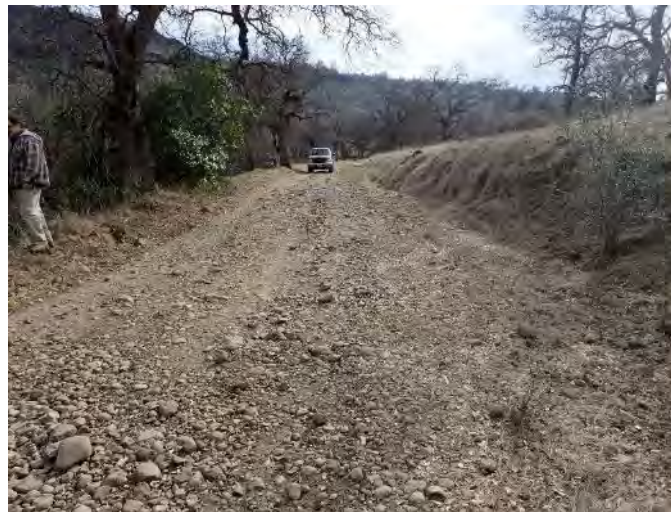
Upper Park Road is slightly “through-cut” (trench-like with berms or cuts on both sides) and flat in cross section. As a result, the road exhibits poor road drainage and actively eroding ditches. Steep road segments beyond the Diversion Dam experience the highest rates of wear. Road outsloping and road surface drainage structures are needed to lessen the flow volumes in the ditch and further disperse surface runoff. As is common on many unpaved roads here and elsewhere, routine road surface maintenance (smoothing) activities are contributing to the slightly through-cut road and berm development; it is a common result of annual maintenance grading and consequent gradual lowering of the road surface (Figure 8). Poor road surface drainage will not improve until the road berm is removed or the road is outsloped, raised and crowned, or paved.

Figure 8. On Upper Park Road a berm has formed after years of grading and road surface erosion. The berm captures and concentrates road runoff, preventing it from being dispersed onto the hillside, and accelerates road surface and ditch erosion rates.

Serious damage to the road structure and road surfaces have been identified with the loss of road drainage, erosion of road surfacing materials and excess standing water on the surface. Ruts and mud indicate that road strength is deteriorating (Weaver et al., 2015). This bermed and through-cut road has locally led to the development of rills and gullies where the road is steep, and to potholes and mud puddles where it is gentle. Outside berms created by maintenance grading have unintentionally concentrated road runoff during winter storms and need to be removed from the outside edge of the road wherever they are preventing proper road drainage.
