**DRAFT**  
**Delineation of Waters of the U.S.**  
**Bidwell Property**  
Chico, California  
June 2007

**Delineation of Waters of the U.S.**

Bidwell Ranch Property

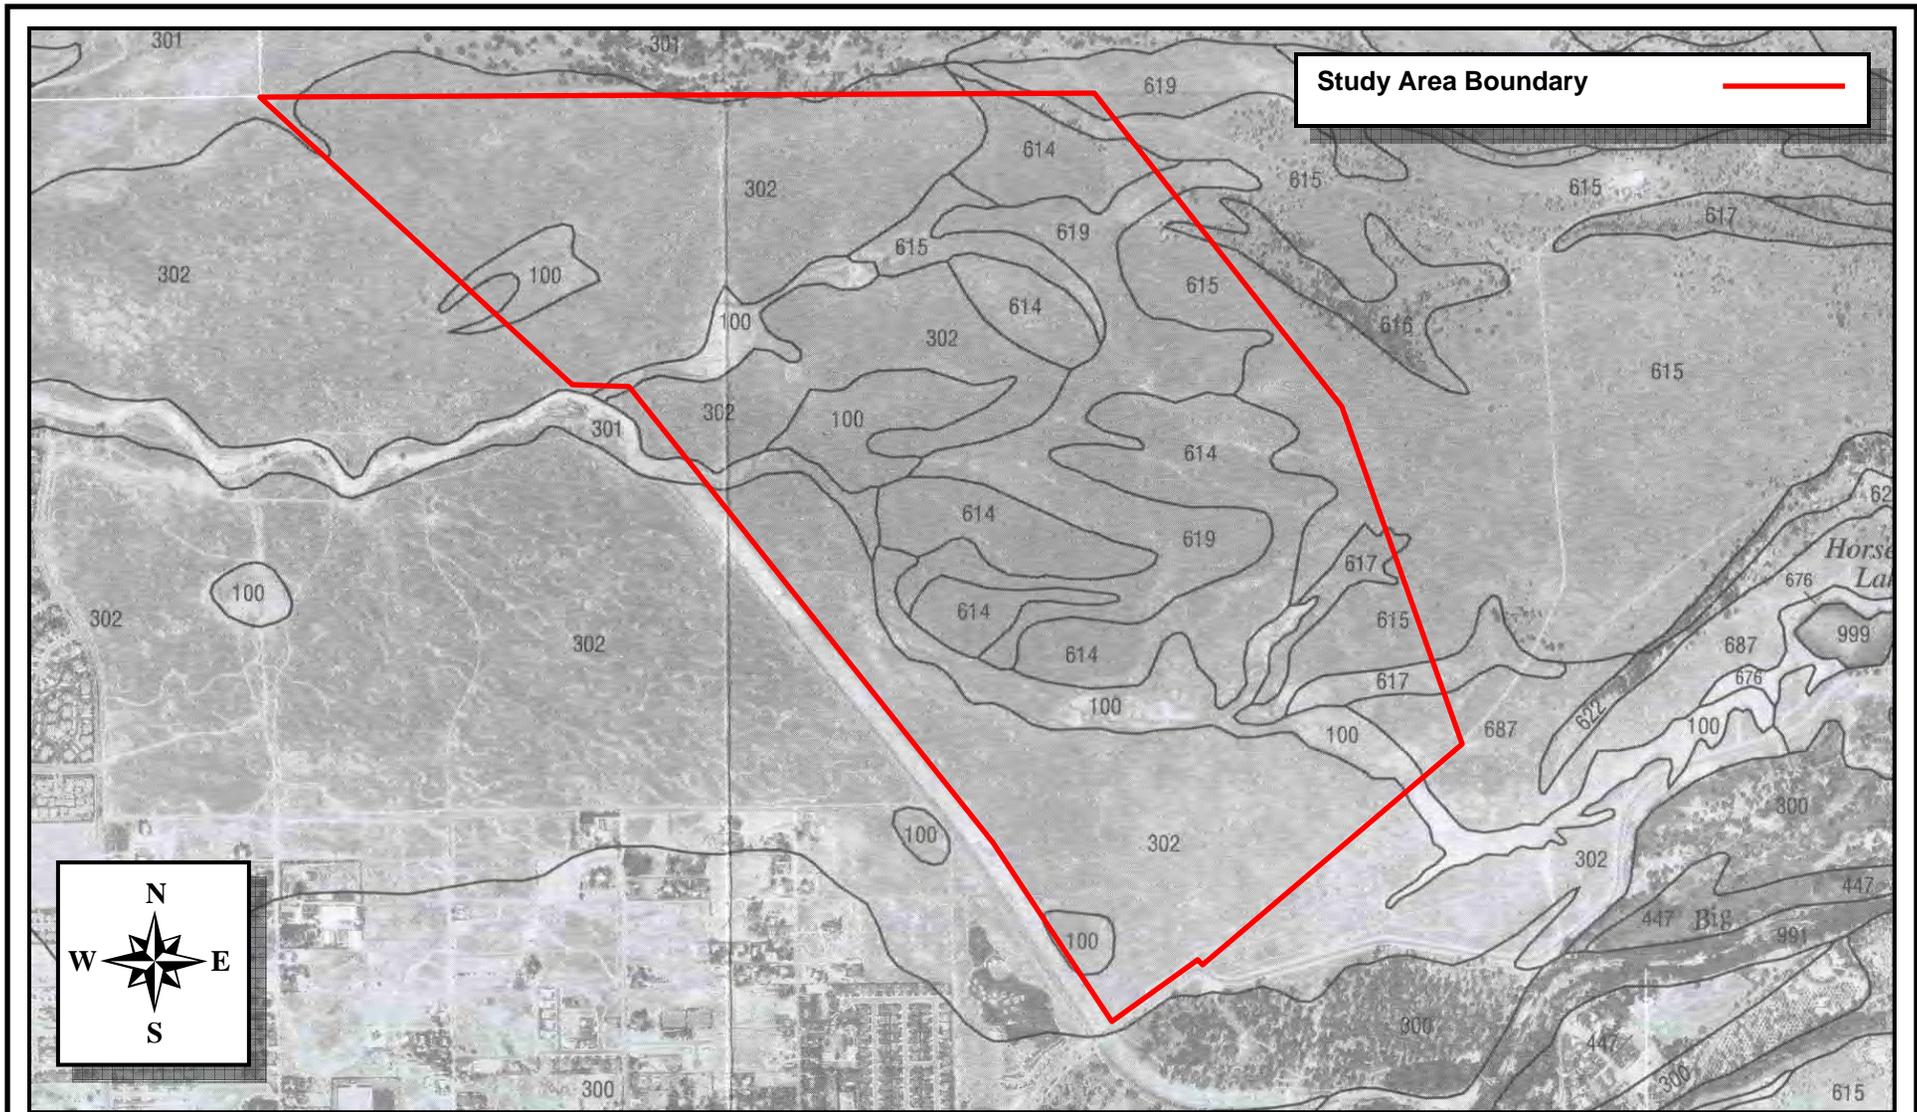
**FIGURE 3**  
**Soil Survey Map**

Nine soil map units occur within the study area according to the *Soil Survey of Butte Area, California, Parts of Butte and Plumas Counties* (Natural Resources Conservation Service et al. 2006). A copy of the soil survey map for the study area is included as Figure 3. The nine identified map units are listed and described below:

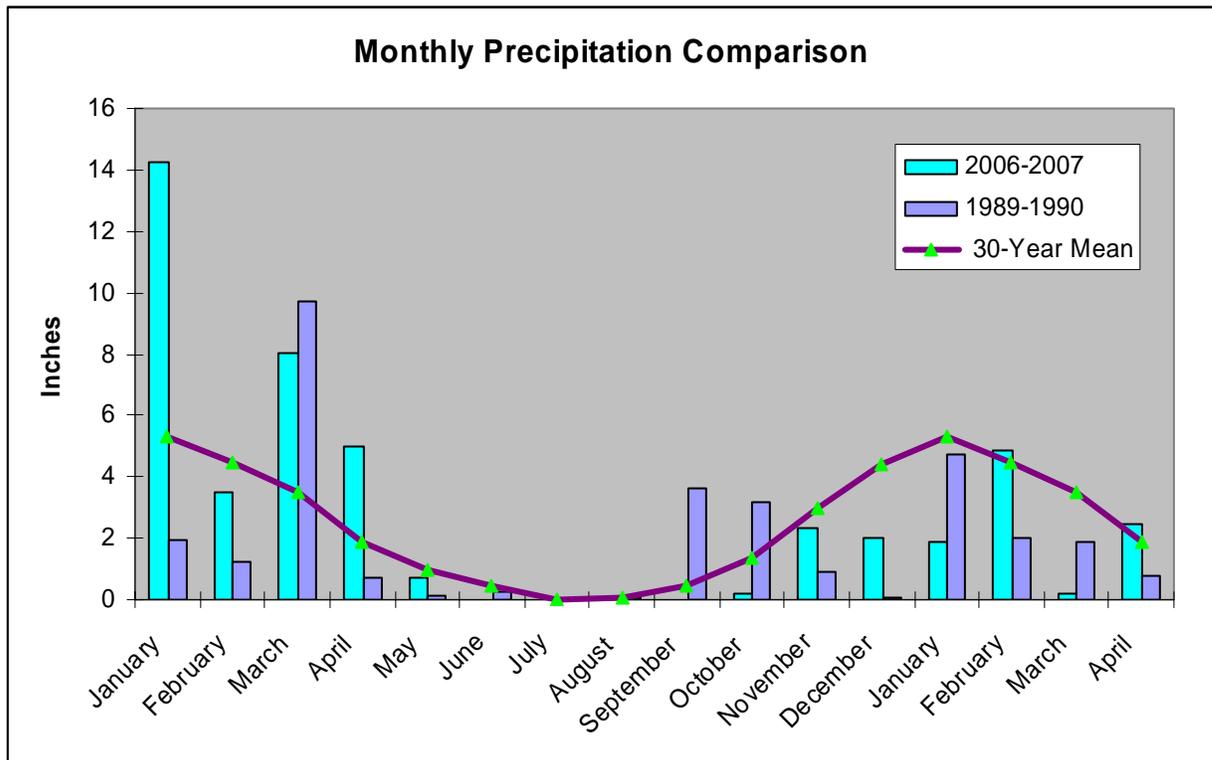
**Figure 4. Monthly precipitation data from the nearest weather stations, Chico and Oroville.**

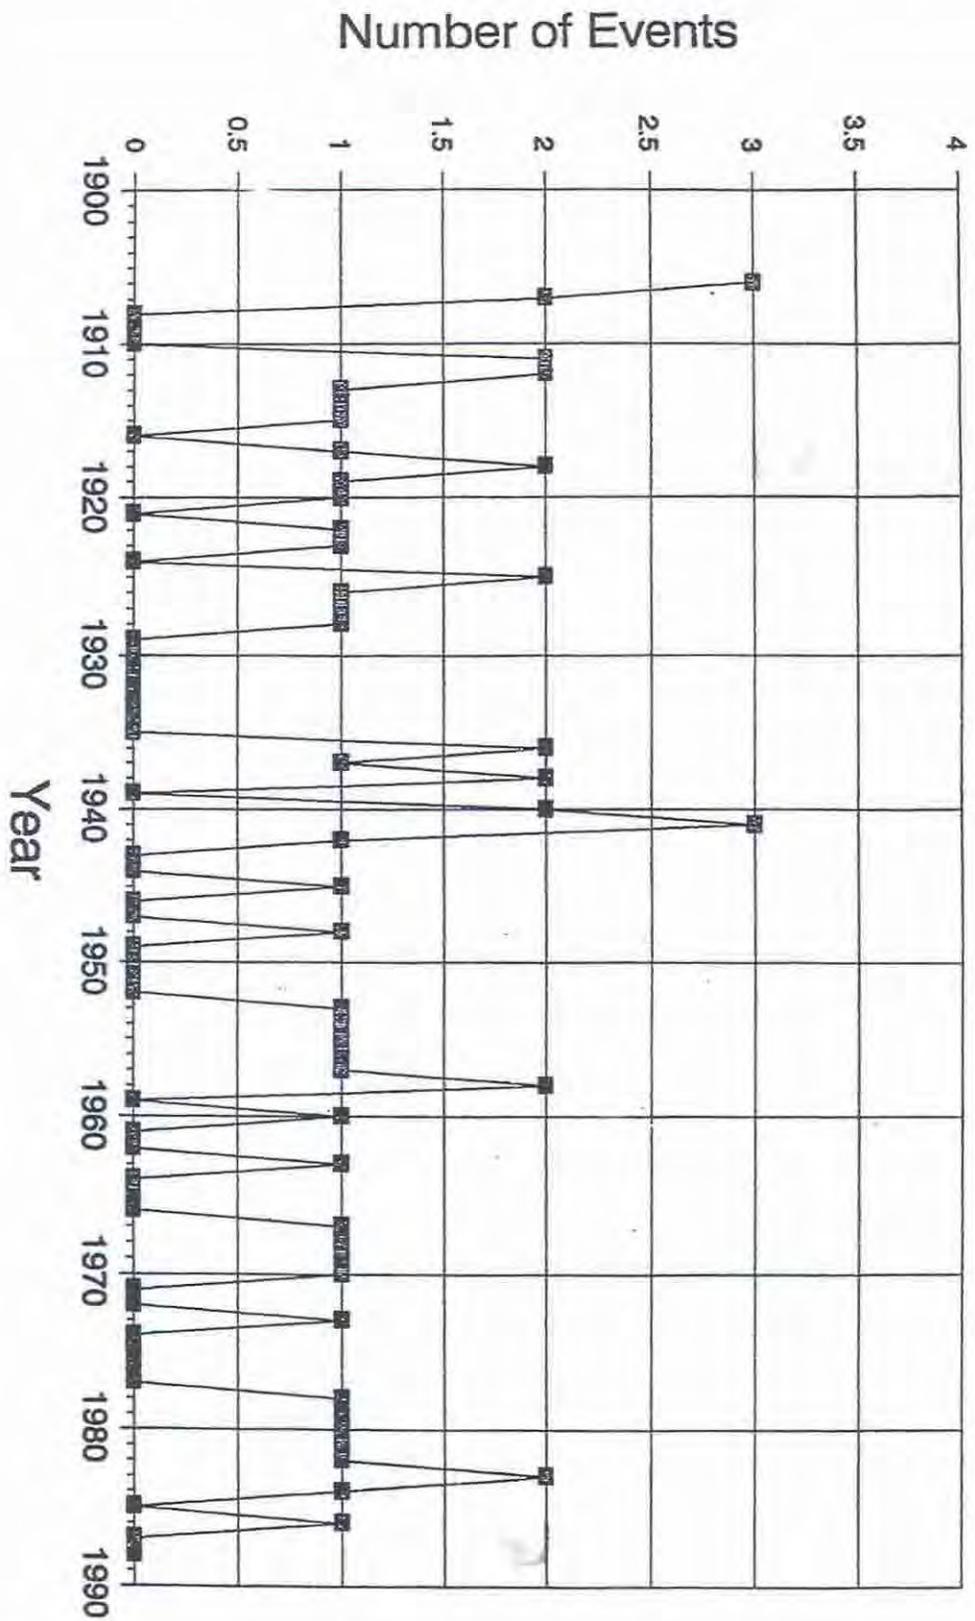
Figure 4. Annual Number of Consecutive Storms Each Exceeding 0.5 Inch (24-Hour Period) and Separated by a Period of 3-4 Days

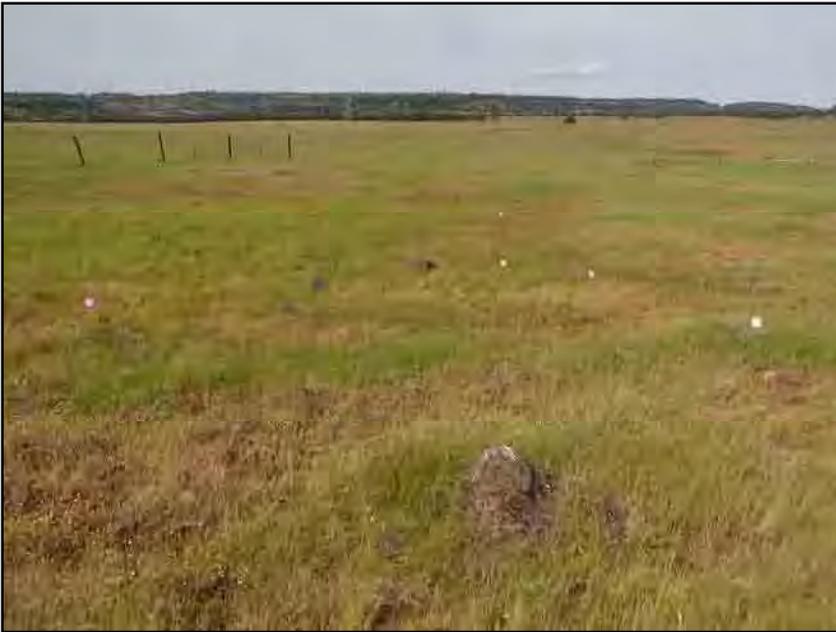
**Photo 1**

View of vernal pool feature VP-250 in the southern portion of the study area, looking east. The white pin flags represent Data Point-1 (left/wetland) and Data Point-2 (right/upland). The pink pin flags represent the delineated wetland boundary.

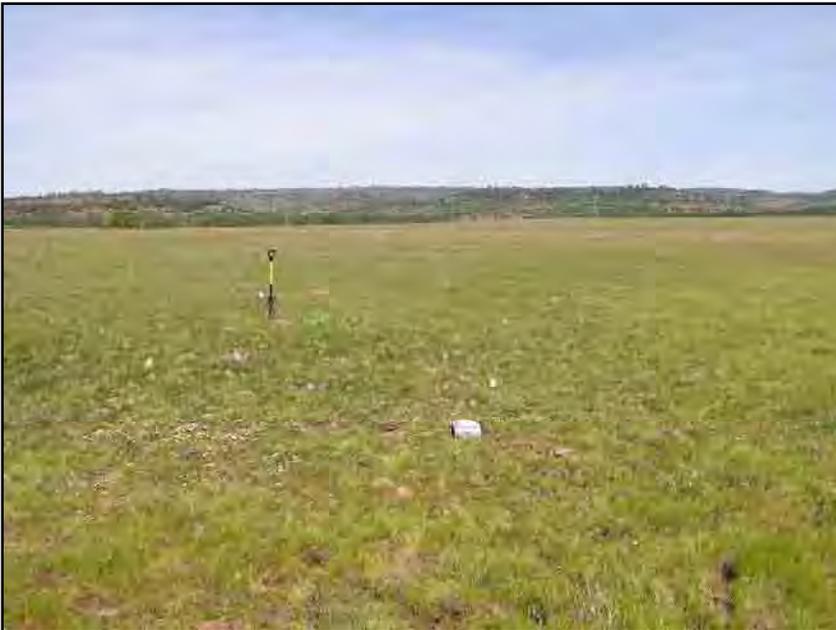
**Photo 2**

View of clay flat feature CF-1 in the central portion of the study area, looking northeast. The white flags represent Data Point-3 (right/wetland) and Data Point-4 (left/upland). The pink flags represent the delineated wetland boundary.

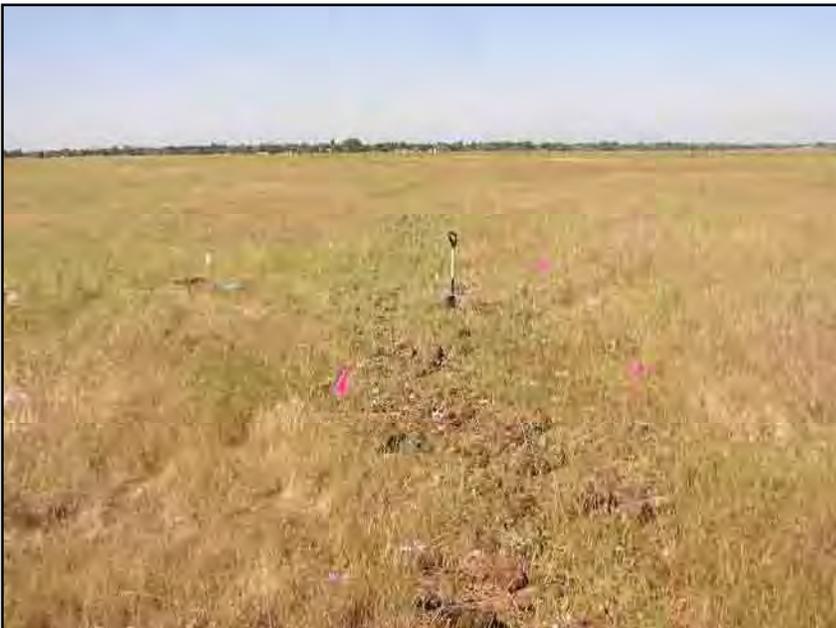
**Photo 3**

View of vernal swale feature VS-8a in the northwest portion of the study area, looking west. The white flags represent Data Point-5 (shovel/wetland) and Data Point-6 (left/upland). The pink flags represent the delineated wetland boundary.

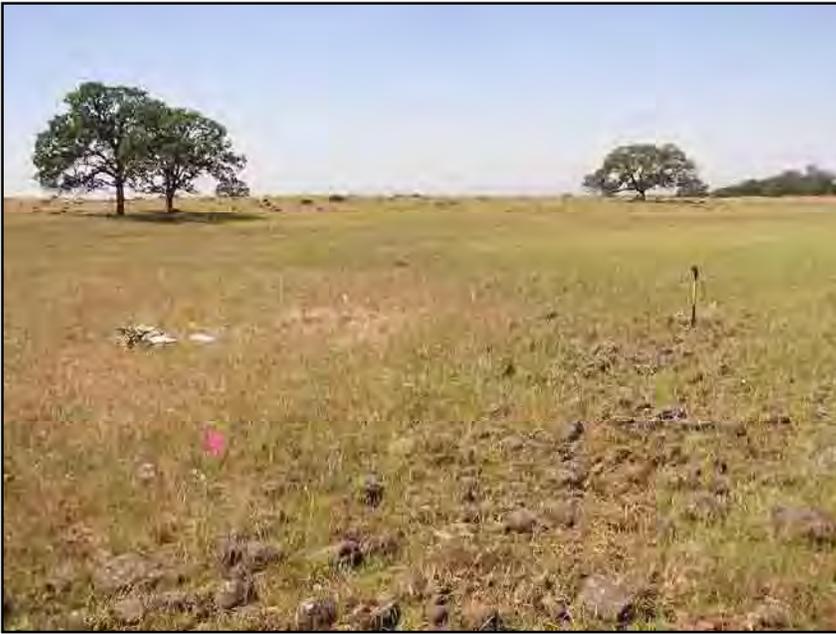
**Photo 4**

View of clay flat feature CF-10 at the northeast corner of the study area, looking west. The white flags represent Data Point-7 (left/upland) and Data Point-8 (shovel/wetland). The pink flags represent the delineated wetland boundary.

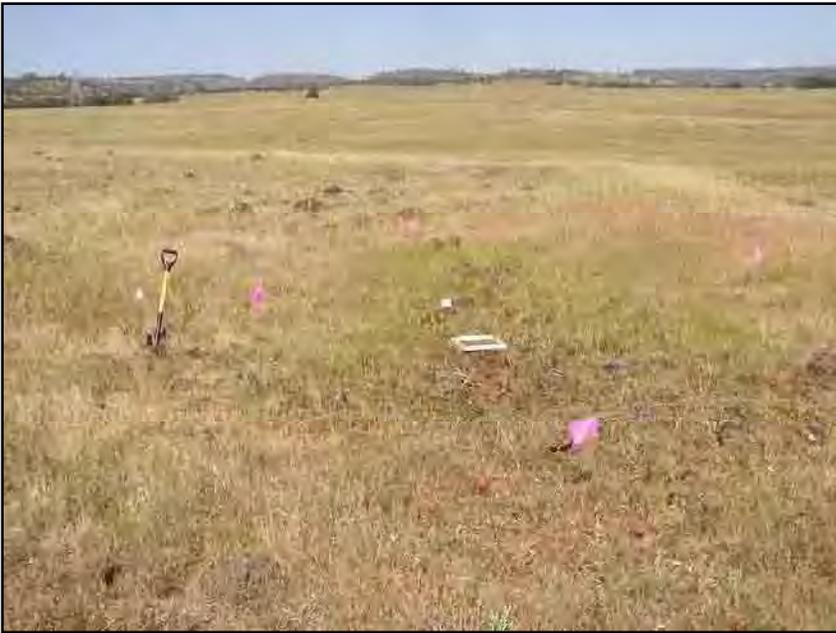
**Photo 5**

View of vernal pool feature VP-345 at the central portion of the study area, looking northeast. The white pin flags represent Data Point-9 (shovel/upland) and Data Point-10 (right/wetland). The pink pin flags represent the delineated wetland boundary.

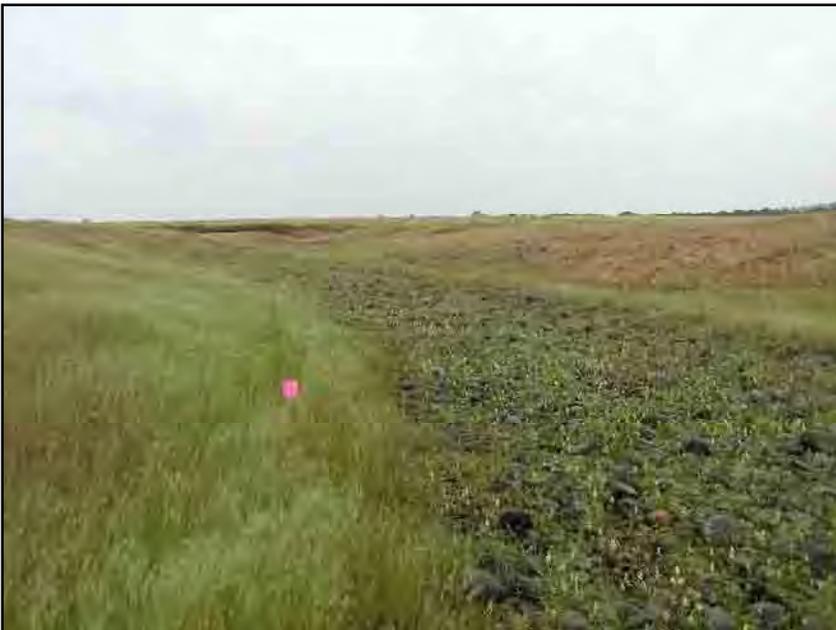
**Photo 6**

View of ephemeral creek feature EC-16, looking north. The pink pin flags represent the delineated ordinary high water mark.

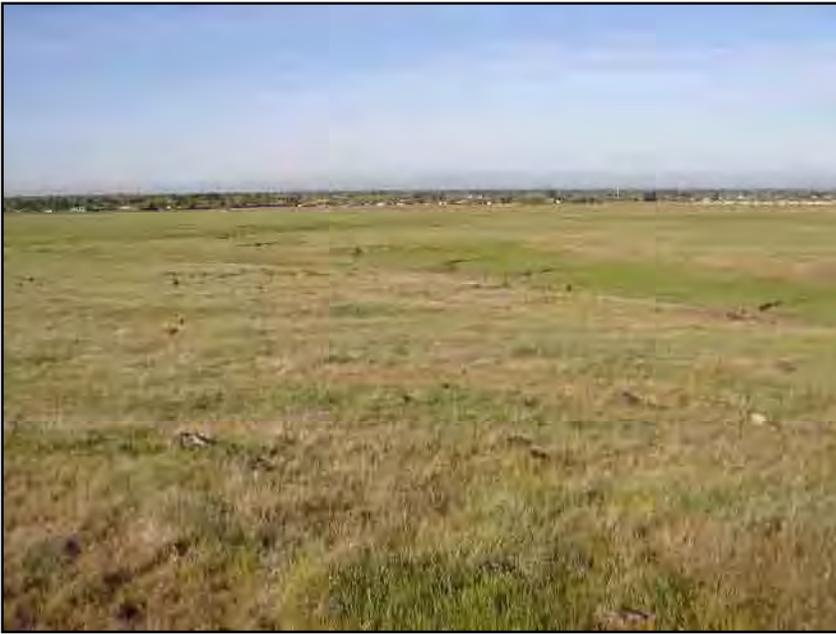
**Photo 7**

Landscape view of the south-central portion of the study area, looking west from near the east boundary. The channel of ephemeral creek feature EC-5 can be seen in the small valley running right to left.

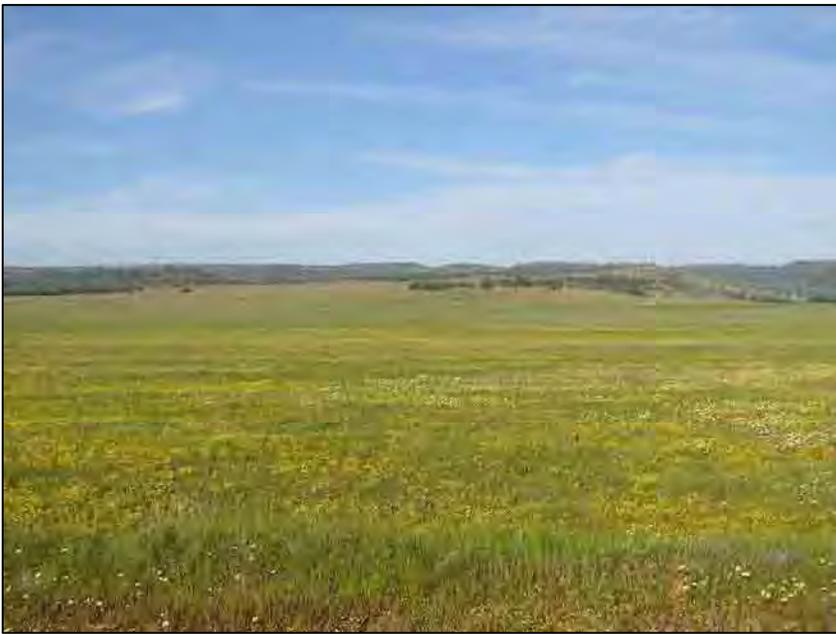
**Photo 8**

Several clay flats were impacted by heavy equipment, as noted in the Land Use and Past Impacts section above. A review of historical aerial photographs indicates that this area was once a vernal pool and vernal swale complex. The two SMU's in the impacted area are Anita-Galt complex (SMU-100) and the Redtough-Redswale complex (SMU-302). The great majority of delineated wetlands within the study area are on these two SMU's. The past impacted area is relatively level, and the bladed markings cut several inches deep into the clay. Within and near these cuts, vernal pool species have either recruited to or regenerated after being disturbed. The vernal pool plant species growing in these few impacted or created clay flat wetlands very gradually feather out and into an open annual grassland community (Appendix E, Photo 8).

Landscape view of the southern portion of the study area, looking east from the west boundary. Clay flat features CF-20 and CF-21 can be seen in the foreground. This area appears to have been a former vernal pool/vernal swale complex that was significantly altered by past land leveling activities.

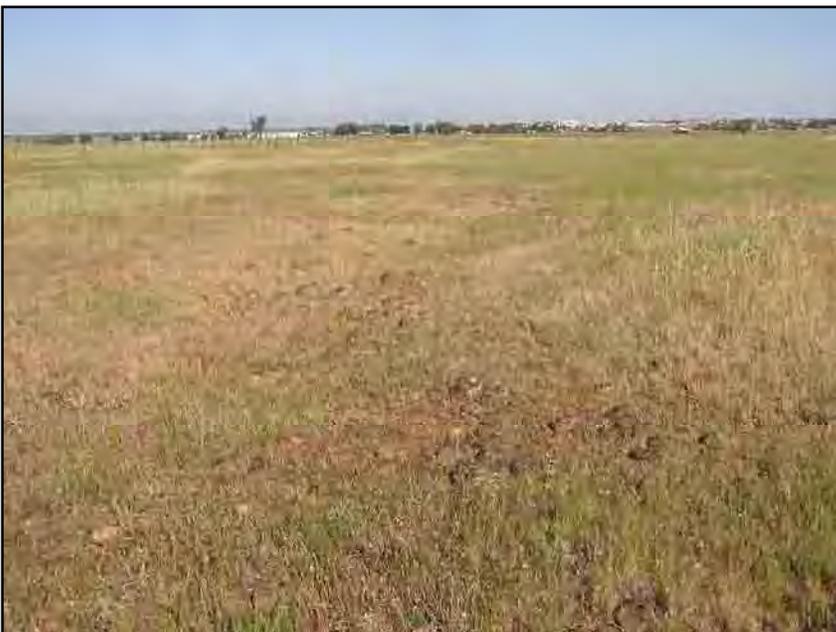
**Photo 9**

View of the northwestern portion of the study area, looking north. A total of 8.43 acres of jurisdictional intermound ephemeral drainage wetlands were identified in a previously-verified delineation (Jones & Stokes Associates, Inc. 1990) on this northern terrace (Appendix D).
