# INITIAL SITE ASSESSMENT

## **Pomona Avenue Bridge Replacement Chico, California Existing Bridge No. 12C-0328**

Subject: **Initial Site Assessment**  
Pomona Avenue Bridge Replacement Project  
Chico, California  
Existing Bridge No. 12C-0328

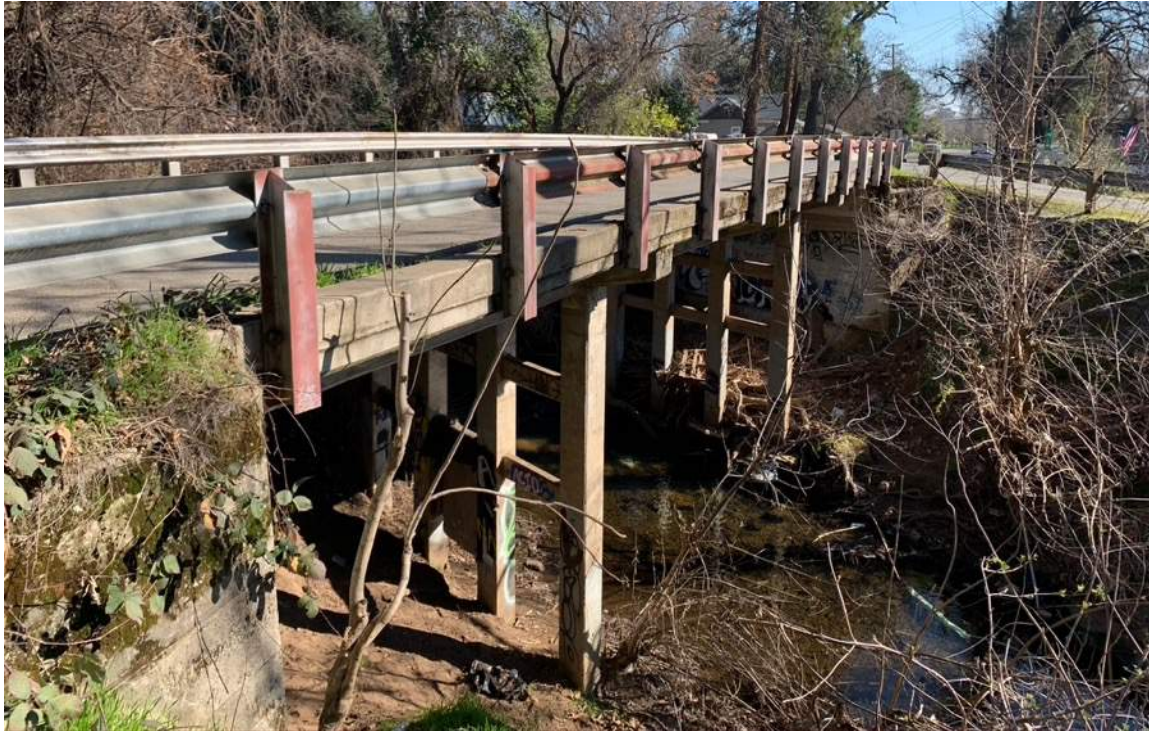
- Two-lane bridge with an asphalt-paved concrete deck, concrete abutments, and two concrete bents.
- Painted steel guard rails on bridge supported on painted steel posts (silver color). This paint appears to be in poor condition, with the primer paint clearly visible in many areas.

Photo 1. Southwest side of Pomona Avenue bridge, viewed to the east. 2/6/2020.

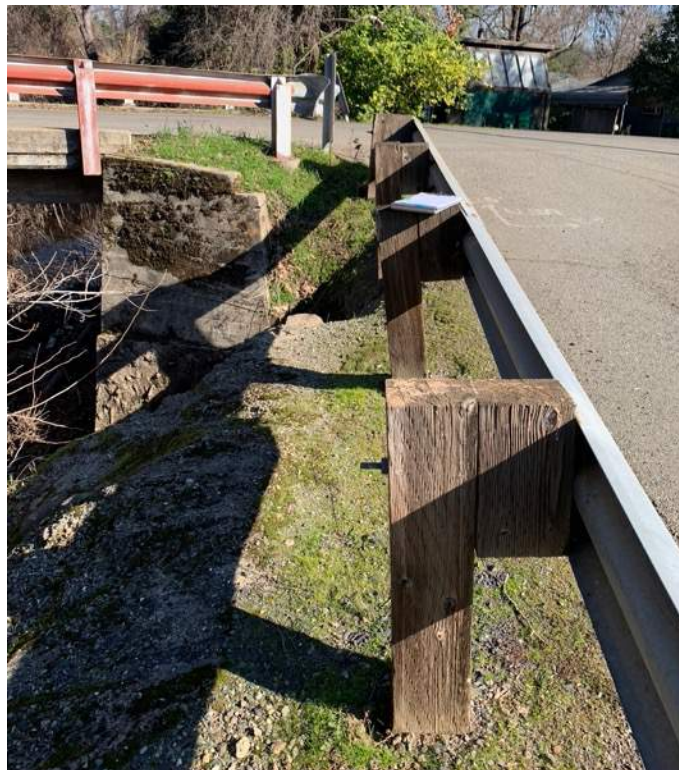
Wood that appeared to be chemically treated was observed supporting the guard rails at the bridge approaches. This material must be handled as TWW as described above.

Photo 2. Treated wood posts at southeast corner of the bridge. 2/6/2020.

Chemically treated wood must be handled as treated wood waste (TWW) and disposed of as hazardous waste. Section 66261.9.5 of DTSC regulations provide alternative management standards (AMS) for treated wood waste. SSP 14-11.14 for TWW is based on AMS regulations. This special standard provision directs the contractor to follow the AMS, including providing training to all personnel that may come in contact with TWW. Training must include, at a minimum, safe handling; sorting and segregating; storage; labeling (including date); and proper disposal methods. Relocation of treated wood utility poles is generally the responsibility of the utility owner.

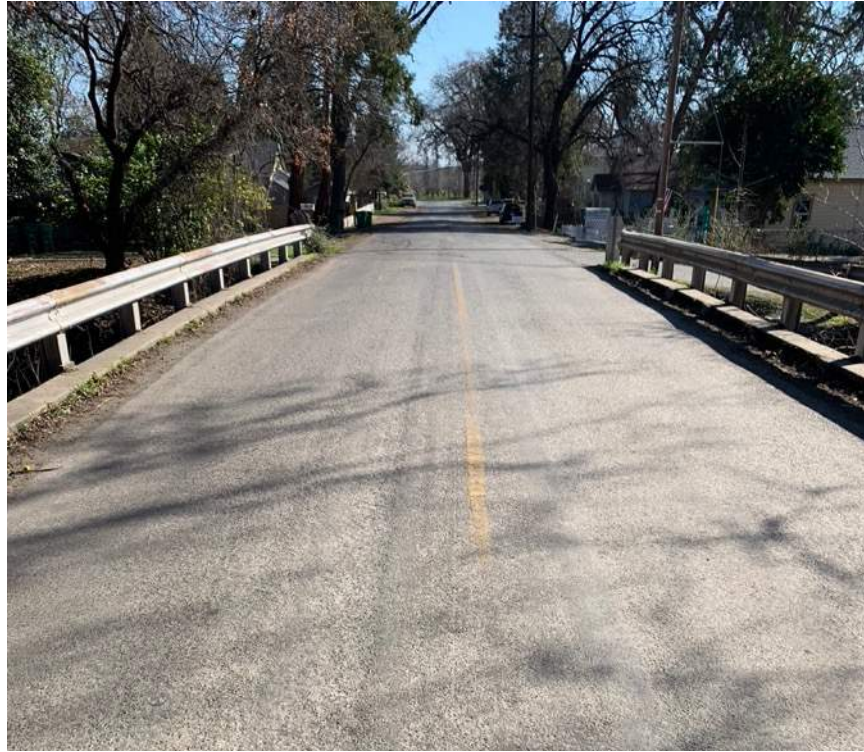
Yellow striping paint in very poor condition was observed on the approaches and the bridge deck. We recommend that this paint be tested for hazardous metals concentrations if project plans call for paint striping to be removed by planing or grinding. SSP 84-9.03C requires a lead compliance plan even if lead is present at non-hazardous concentrations. If the painted asphalt is removed and recycled without grinding or planing the paint, the painted asphalt does not need to be handled as hazardous waste.

Photo 3. Bridge deck, viewed southeast. 2/6/2020.

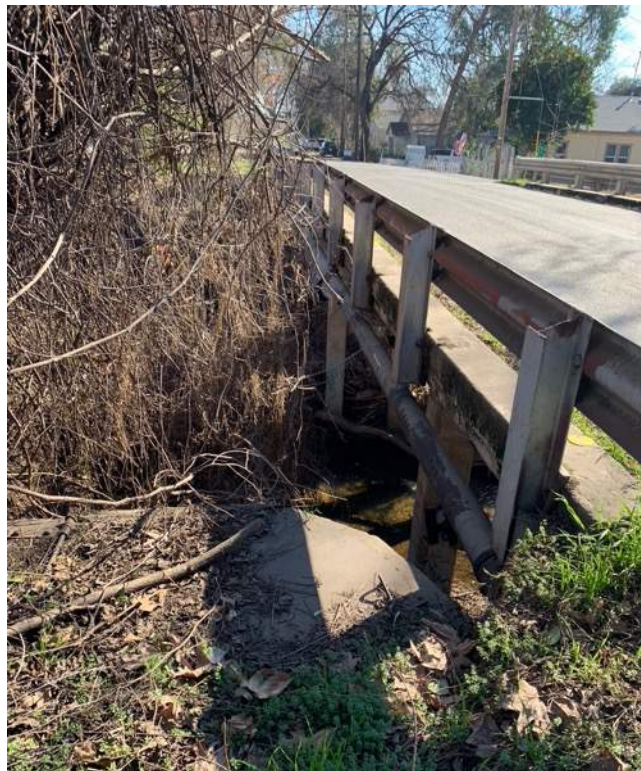
Photo 4. Northeast side of bridge at northeast corner. 2/6/2020.

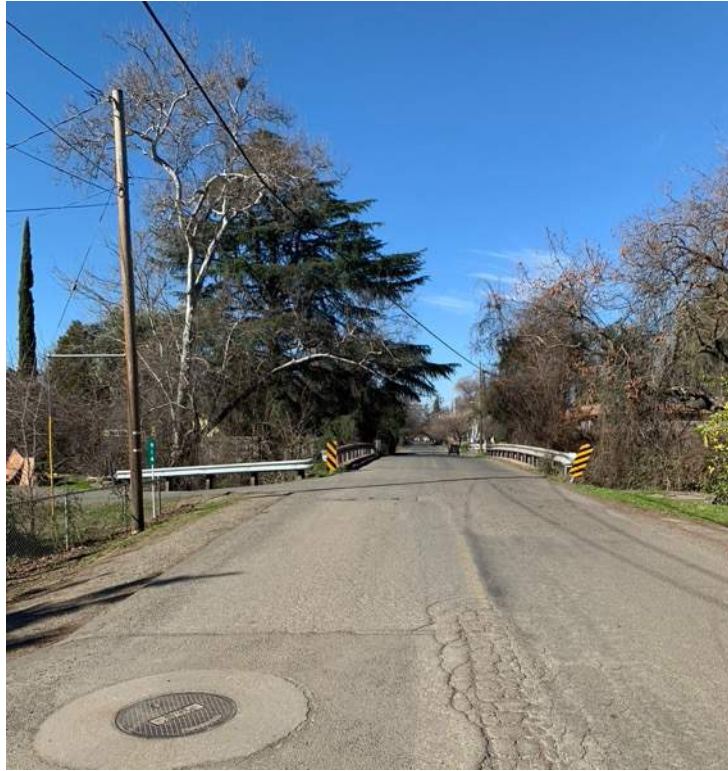
**Photo 5. Eastern approach, viewed toward the northwest. 2/6/19.**

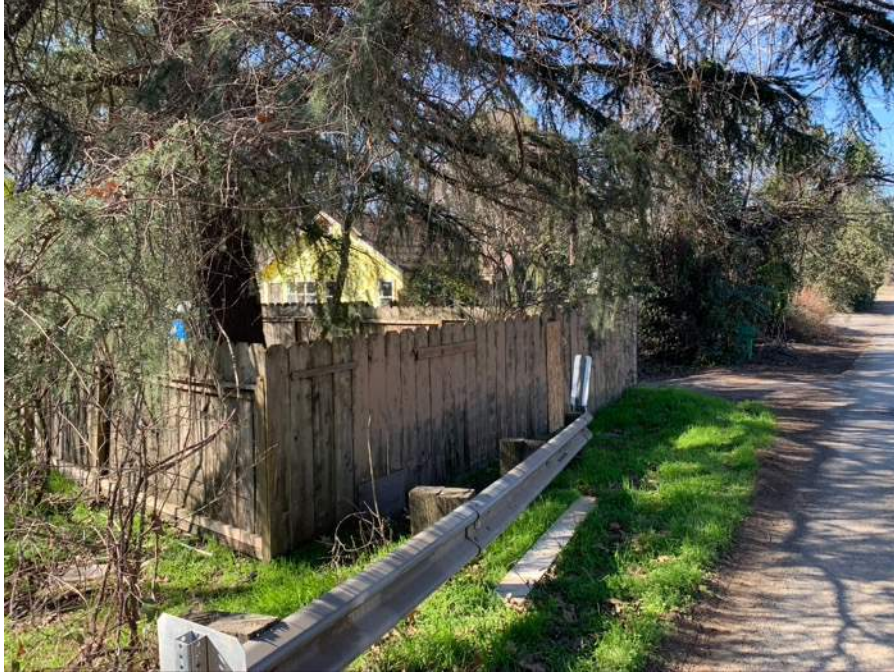
Metal guard rails on the bridge structure and approaches are painted, and this paint system is in poor condition. We recommend that the lead content of this paint be evaluated by a CLA.

**Photo 7. Guard rail at southwest corner of bridge. 2/6/2020.**
