**CITY OF CHICO**  
**BIDWELL PARK AND PLAYGROUND COMMISSION (BPPC)**

Regular Meeting Agenda  
September 25, 2017, 6:30 pm  
Municipal Center - 421 Main Street, Council Chamber

- 5.1. PRESENTATION ON THE FINAL REPORT OF THE UPPER BIDWELL PARK ROAD ASSESSMENT.

**Upper Bidwell Park Road  
Sediment Source Assessment  
and Treatment Action Plan,  
Butte County, California**

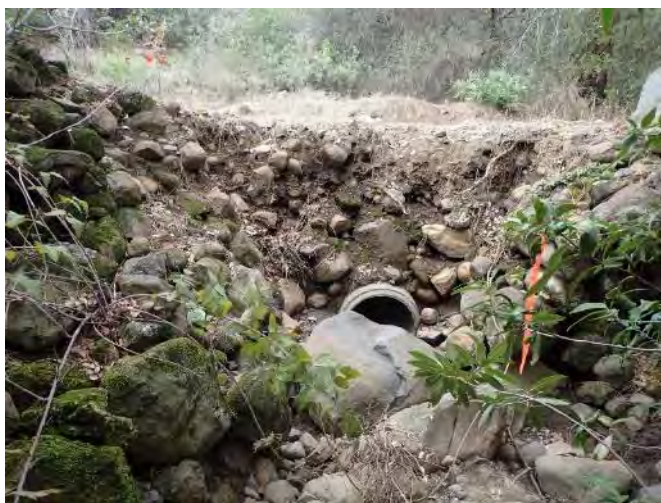
Figure 1. This stream crossing site is plugged by a boulder that dwarfs the concrete culvert inlet. The culvert is undersized for the upslope drainage area and was assigned a high priority for treatment.

Of the 40 inventoried stream crossings, 35 have the potential to divert in the future and 7 of the streams are currently diverted out of their natural stream channels (Table 3). Of the existing 37 culverts at stream crossings, 27 (77%) are undersized and not sufficiently designed for the 100-yr peak storm discharge, and 15 are judged to have a high potential to become plugged by sediment and debris and (Table 3, Figure 1).

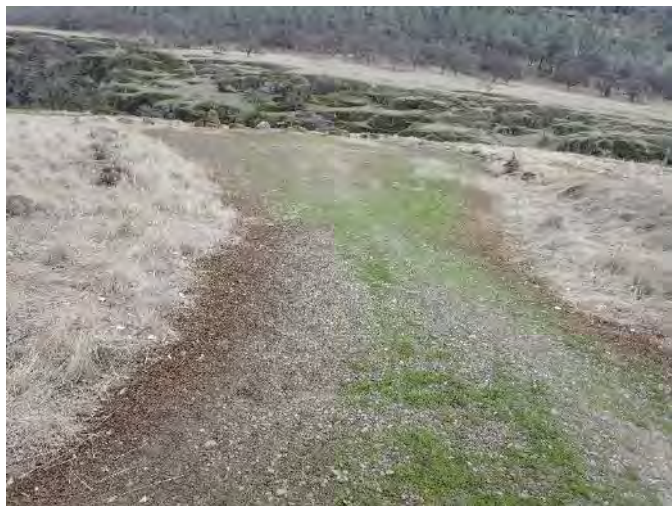
Figure 4. Each individual parking areas showed minimal signs of erosion or sediment delivery. It will important to reduce any potential run-on that may negatively affect these parking areas.

In general, PWA determined that preventing run-on from Upper Park Road is a key factor in erosion prevention of the parking areas. Maintaining Upper Park Road as an insloped road while near the parking areas on the outer edge of the road prevents run-on and consequent erosion. Continued maintenance of the overall area at these generally small-sized parking areas also reduces the area of disturbance which can help reduce the magnitude of parking area erosion. Utilizing large rocks around the perimeter of each parking area is a good method that is currently being used to control off-area vehicle use and it serves to minimize the area of disturbance.

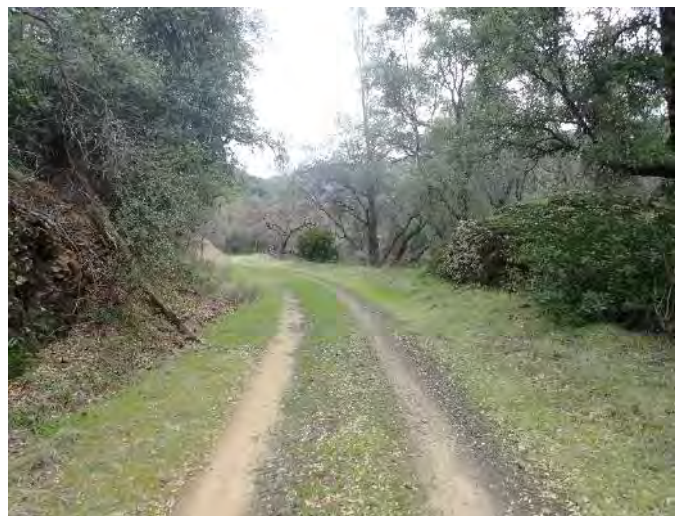
Figure 5. The bare surface area on the road is reduced beyond the gate located at the Diversion Dam Parking Area. Reduced levels of vehicular use can allow vegetation to cover the road and reduce the intensity and magnitude of road-related runoff, erosion and sediment delivery.

Parks Division staff has been concerned that any partial repairs would disturb the existing road substrate, causing increased erosion and further damage. PWA evaluated the visitor access issue and existing conditions of Upper Park Road regarding the Parks Division concerns. Since the closure of the road for vehicular access by visitors, road wear has reduced. We found that beyond the Diversion Dam Parking Area “L” access for visitors with private vehicles should be closed primarily due to the terminus of the road located at mile post 4.40 (Parking Area “U”), which is too small to accommodate visitor parking and emergency vehicles (i.e. fire truck, ambulance, etc.) turn-around point. This issue is mentioned in the BPMMP Appendix E Trails Plan. We agree with the listed Alternative B in the BPMMP

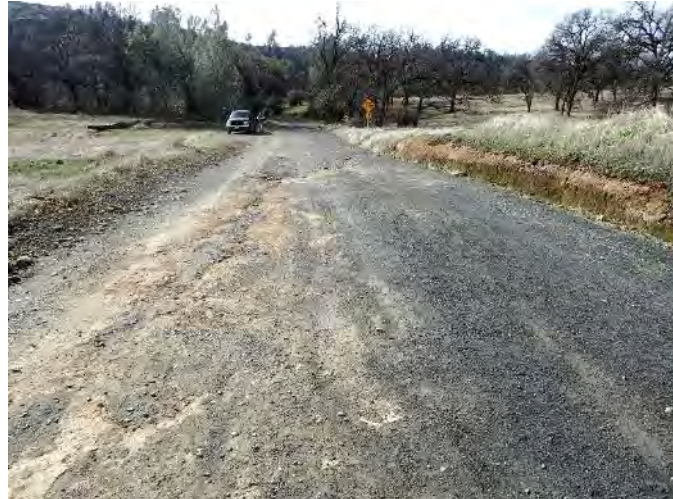
Figure 7. Roads that are flat in cross section, with an outside berm and inside ditch, intercept do not allow the runoff to leave the road. Concentrated road surface and ditch runoff flows down the road with increasing velocity and discharge, creating surface erosion, rills and gullying.

An outsloped road ensures that turbid road runoff and fine sediment eroded from the roadbed will be quickly drained to the outside edge of the road where it can be safely discharged onto vegetation and into undisturbed slopes (see Appendix C for typical design drawings).
