Evaluation of Iron Canyon for Proposed Fish Ladder Structure Repair and Construction

Big Chico Creek in Upper Bidwell Park

PHOTOMOSAIC 1 OF WEST CANYON WALL

Date	Project No.	Drawing No.	Issue
5/24/06	SE05–071	3	
Scale: NO SCALE	File Name: MOSAIC 1.dwg

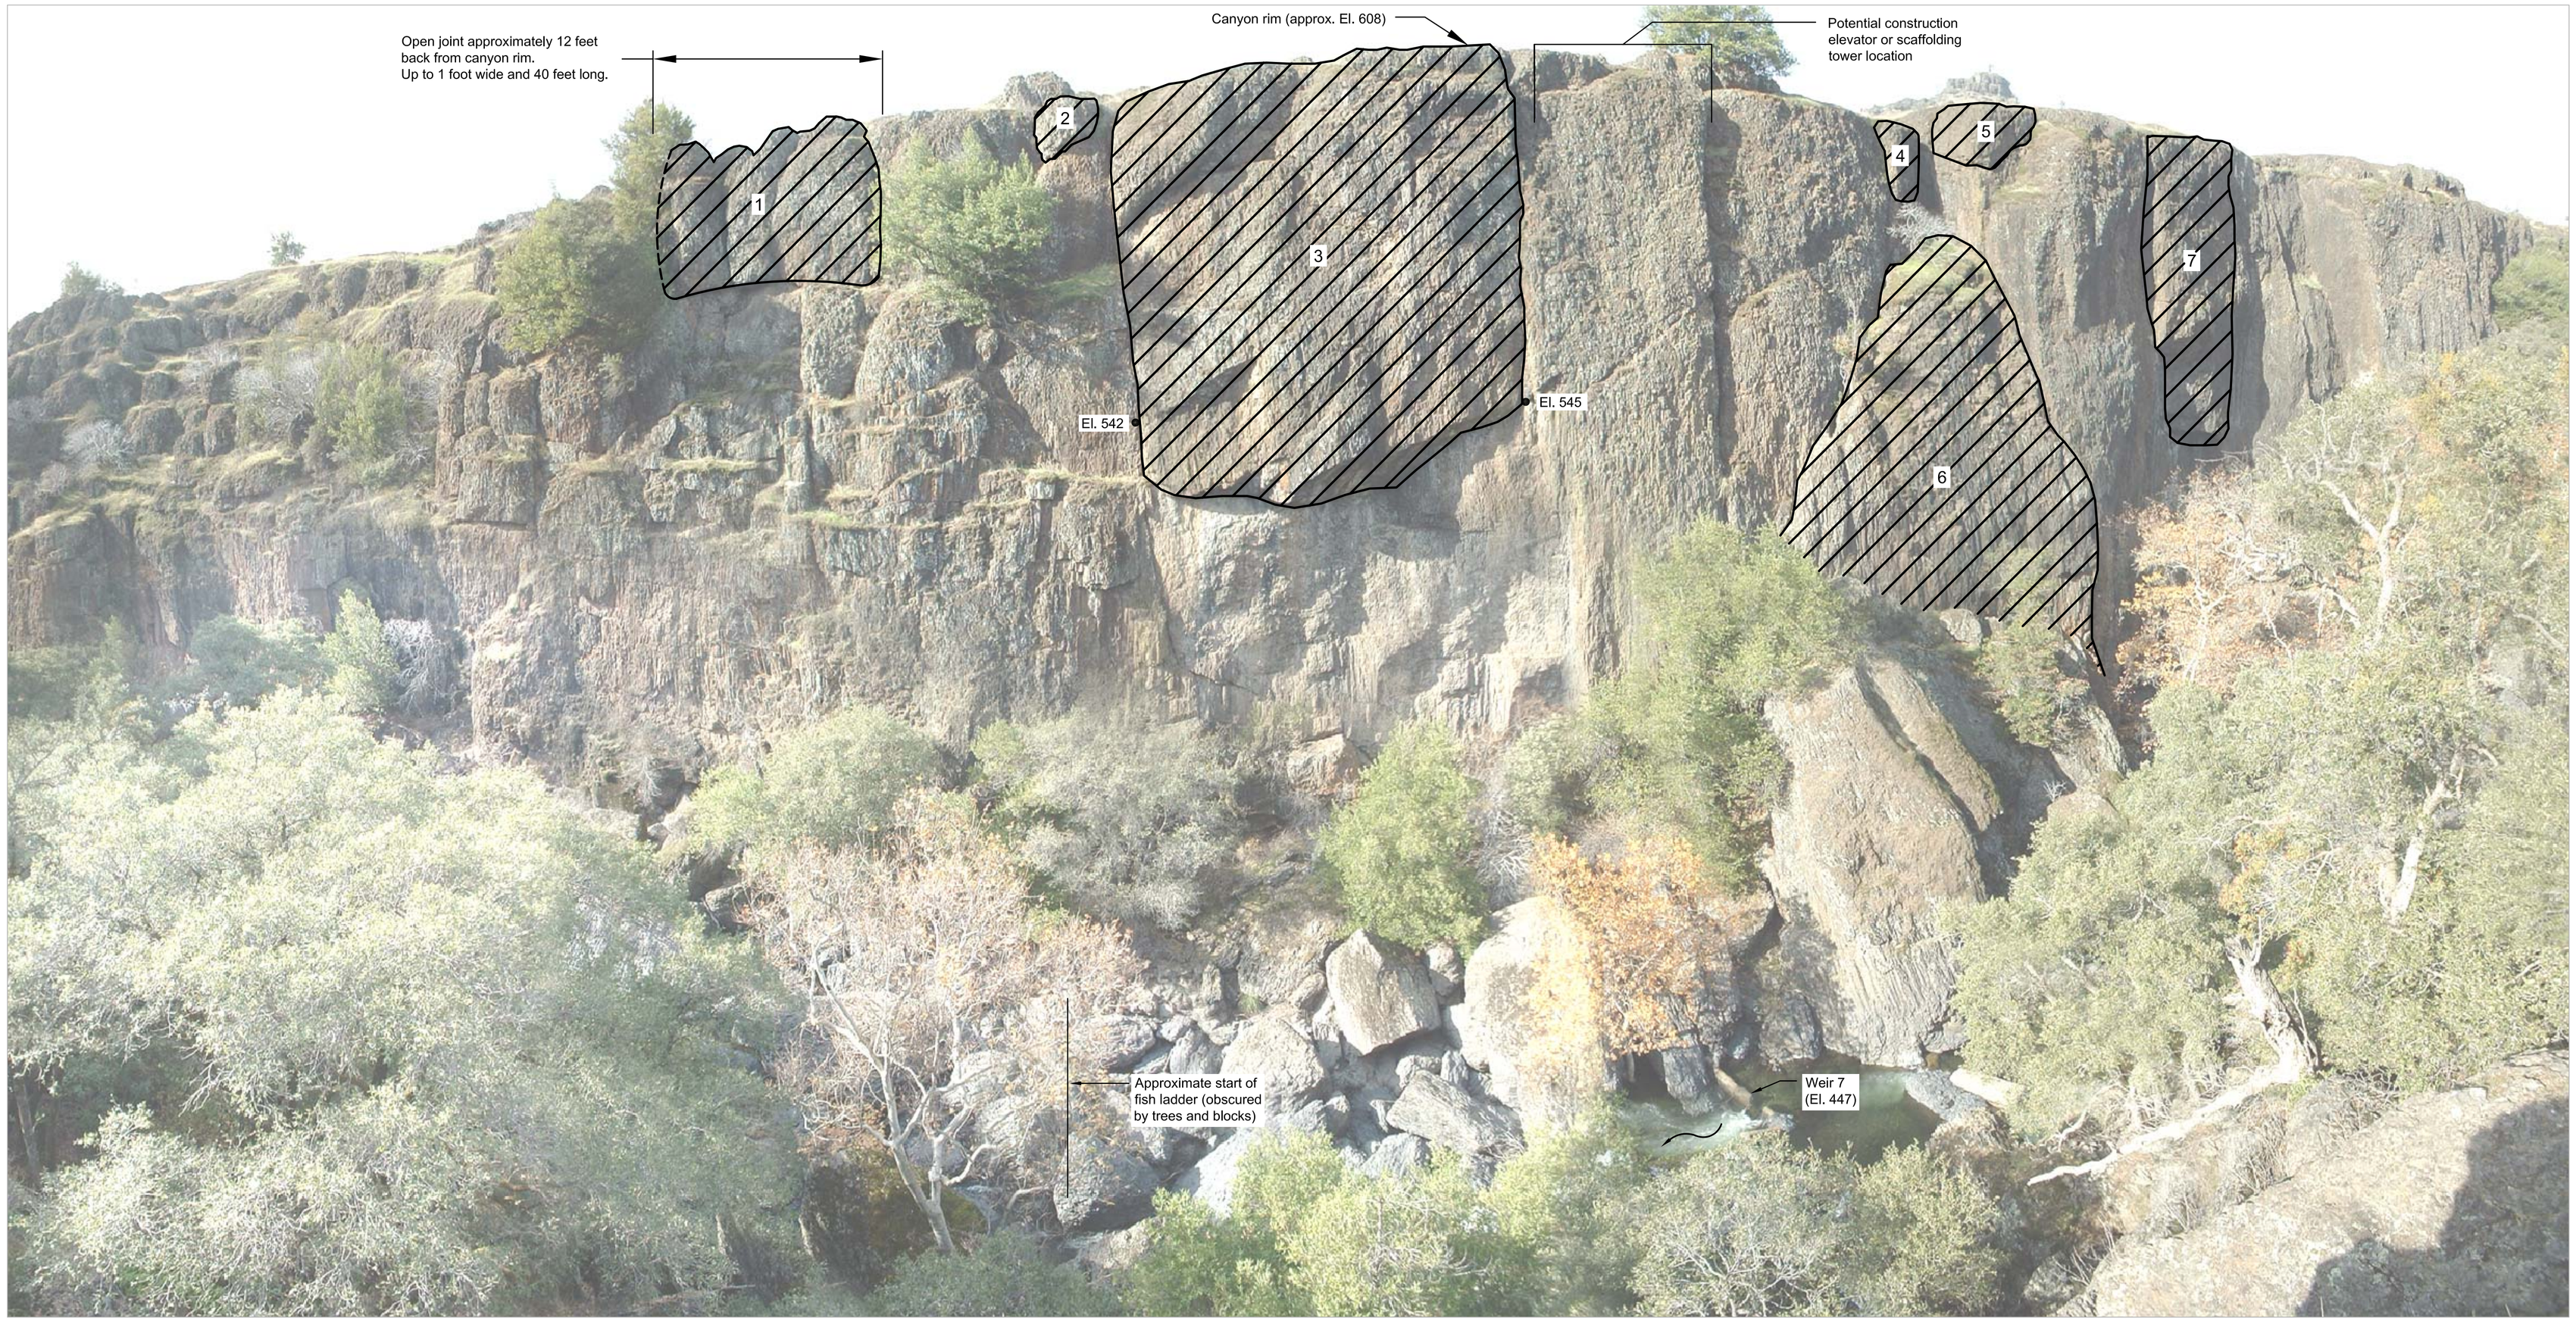
1 — Blocks judged to have the potential for static and/or seismic instability as enumerated in evaluation report. Limits dashed where inferred. Blocks numbered for discussion purposes in evaluation report.
