Evaluation of Iron Canyon for Proposed Fish Ladder Structure Repair and Construction

Big Chico Creek in Upper Bidwell Park

PHOTOMOSAIC 2 OF WEST CANYON WALL

Date: 5/24/06
Scale: NO SCALE
Project No.: SE05-071
File Name: MOSAIC 2.dwg
Drawing No.: 4
Issue:

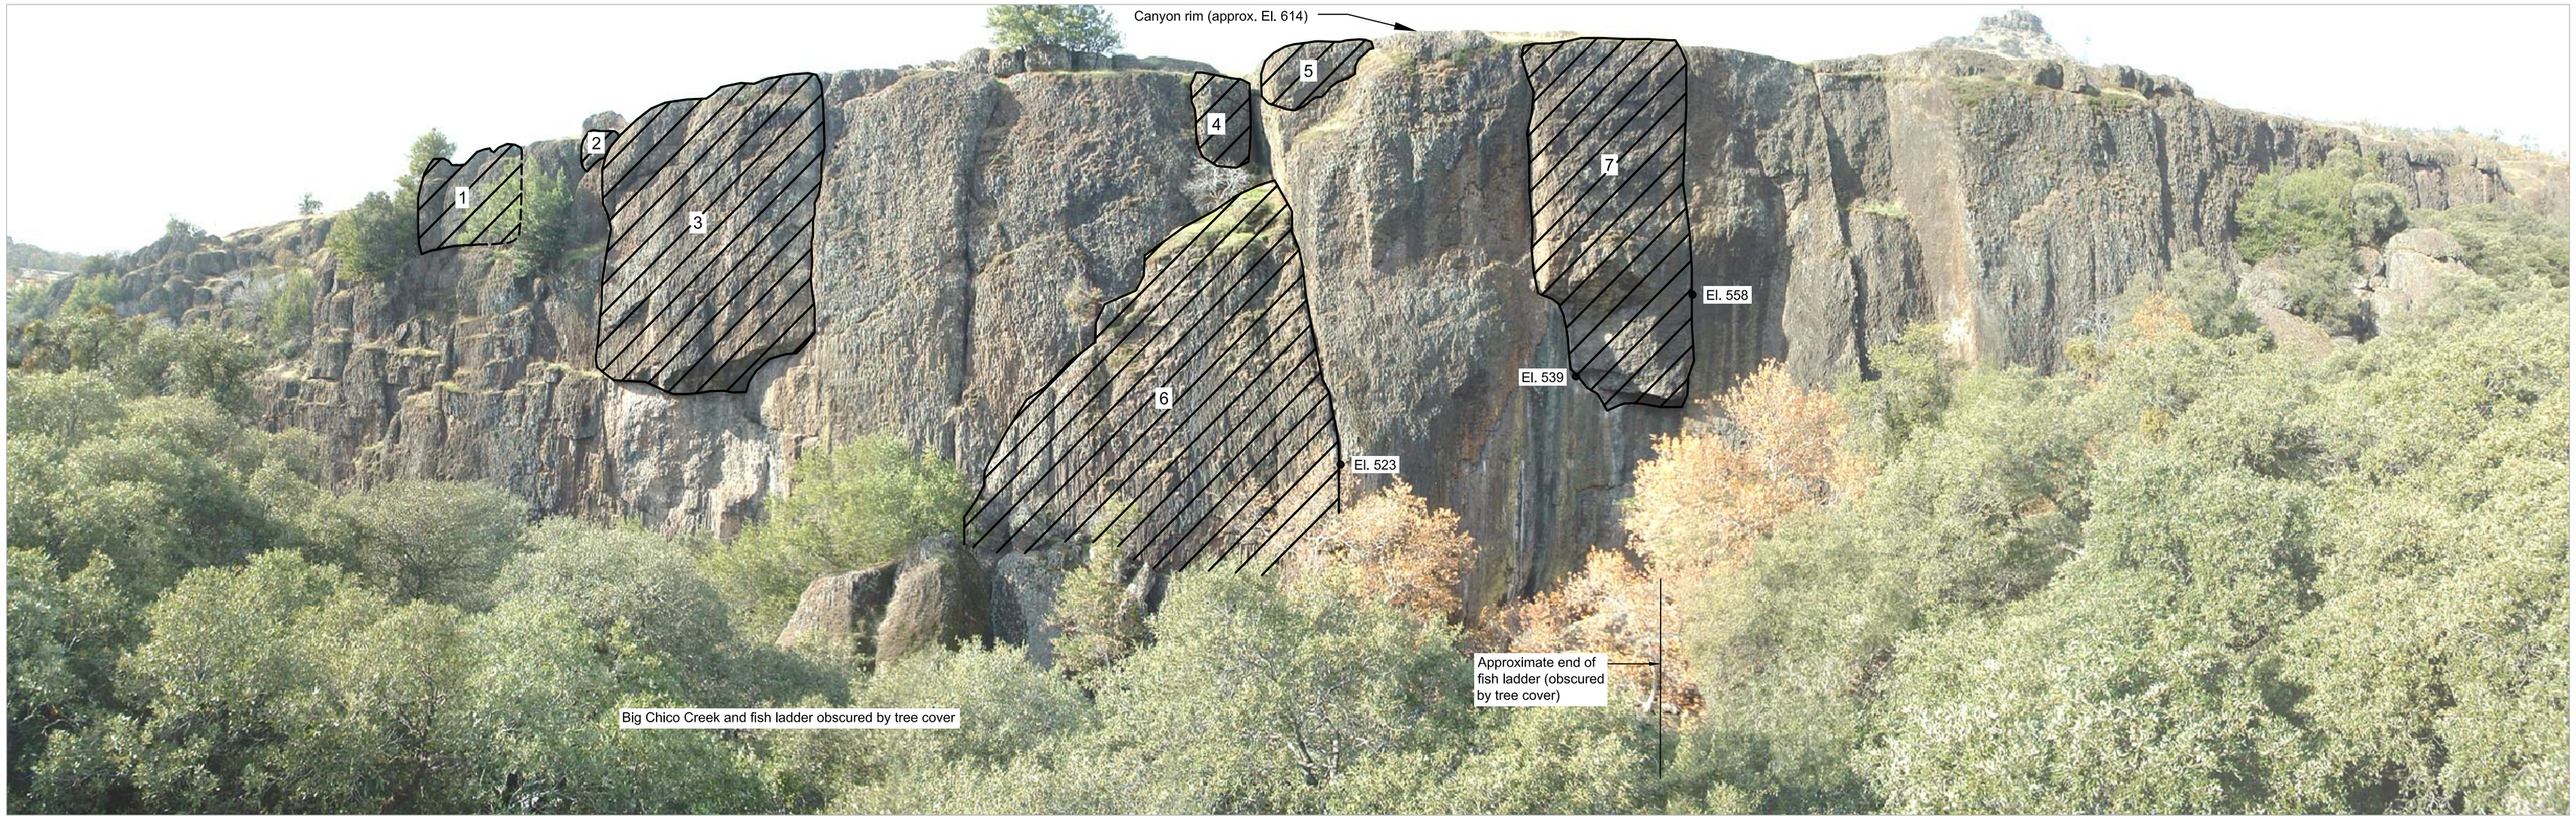
1 — Blocks judged to have the potential for static and/or seismic instability as enumerated in evaluation report. Limits dashed where inferred. Blocks numbered for discussion purposes in evaluation report.
