**Upper Bidwell Park Road
Sediment Source Assessment
and Treatment Action Plan,
Butte County, California**

PWA Report No. 171028801
May, 2017

City of Chico, Parks Division

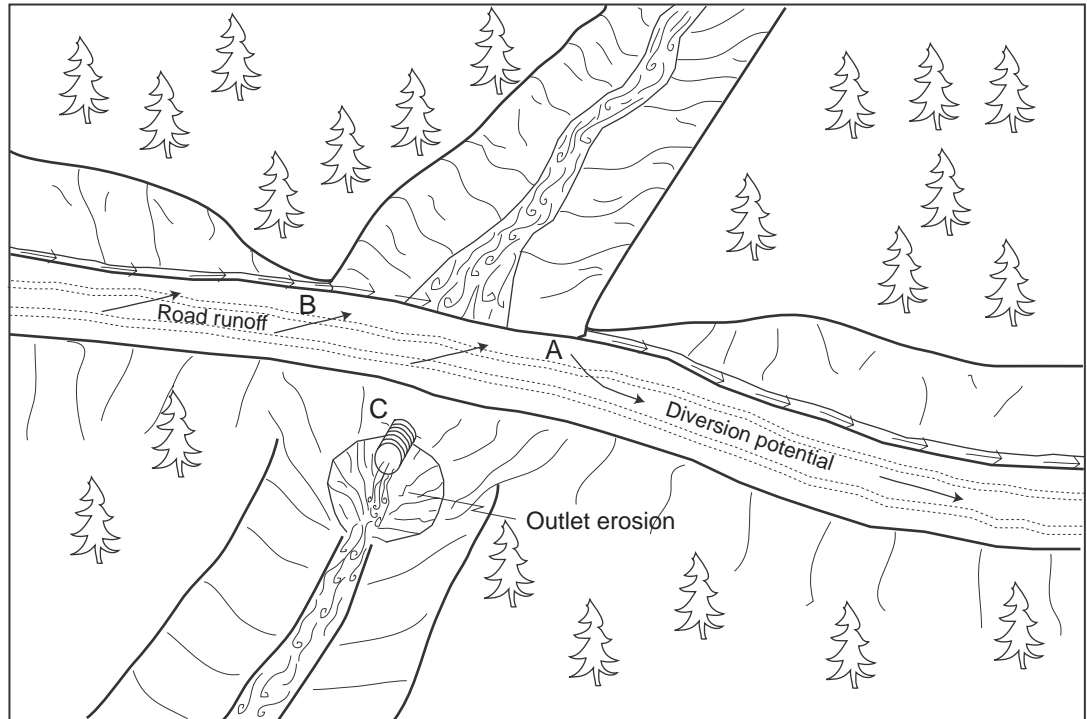
Problem condition (before)

- A - Diversion potential
- B - Road surface and ditch drain to stream
- C - Undersized culvert high in fill with outlet erosion

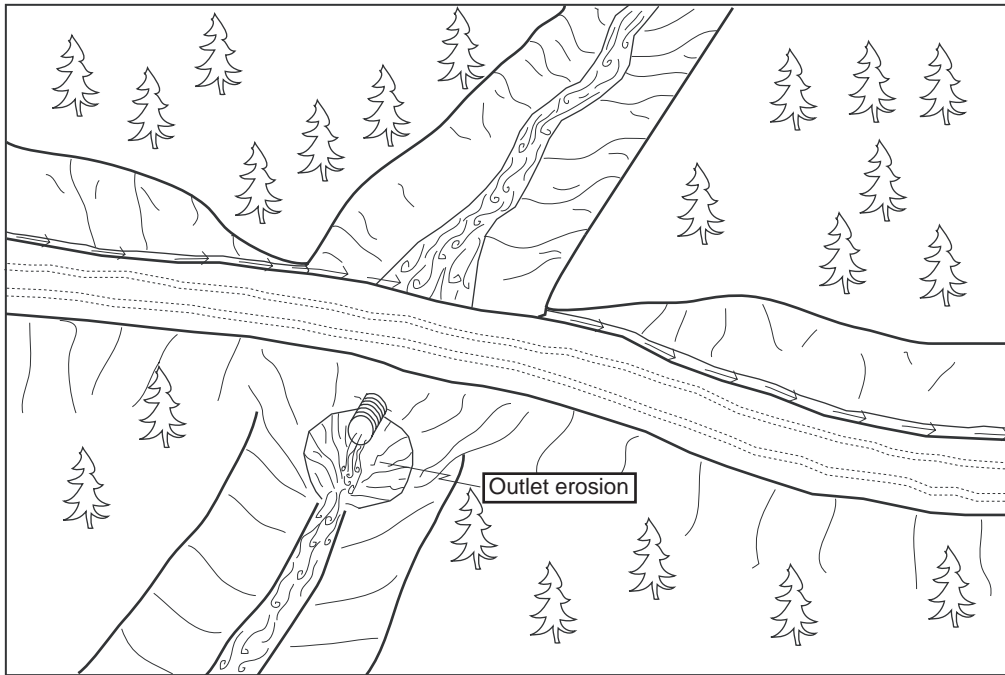
Problem: Culvert set high in outboard fill has resulted in scour of the outboard fill face and natural channel.
