CITY OF CHICO MEMORANDUM

TO: TRAILS CREW DATE: 4/4/11
FROM: DAN EFSEAFF FILE:
SUBJECT: 2011 MIDDLE TRAIL PROJECT WORK (SEGMENT 6)

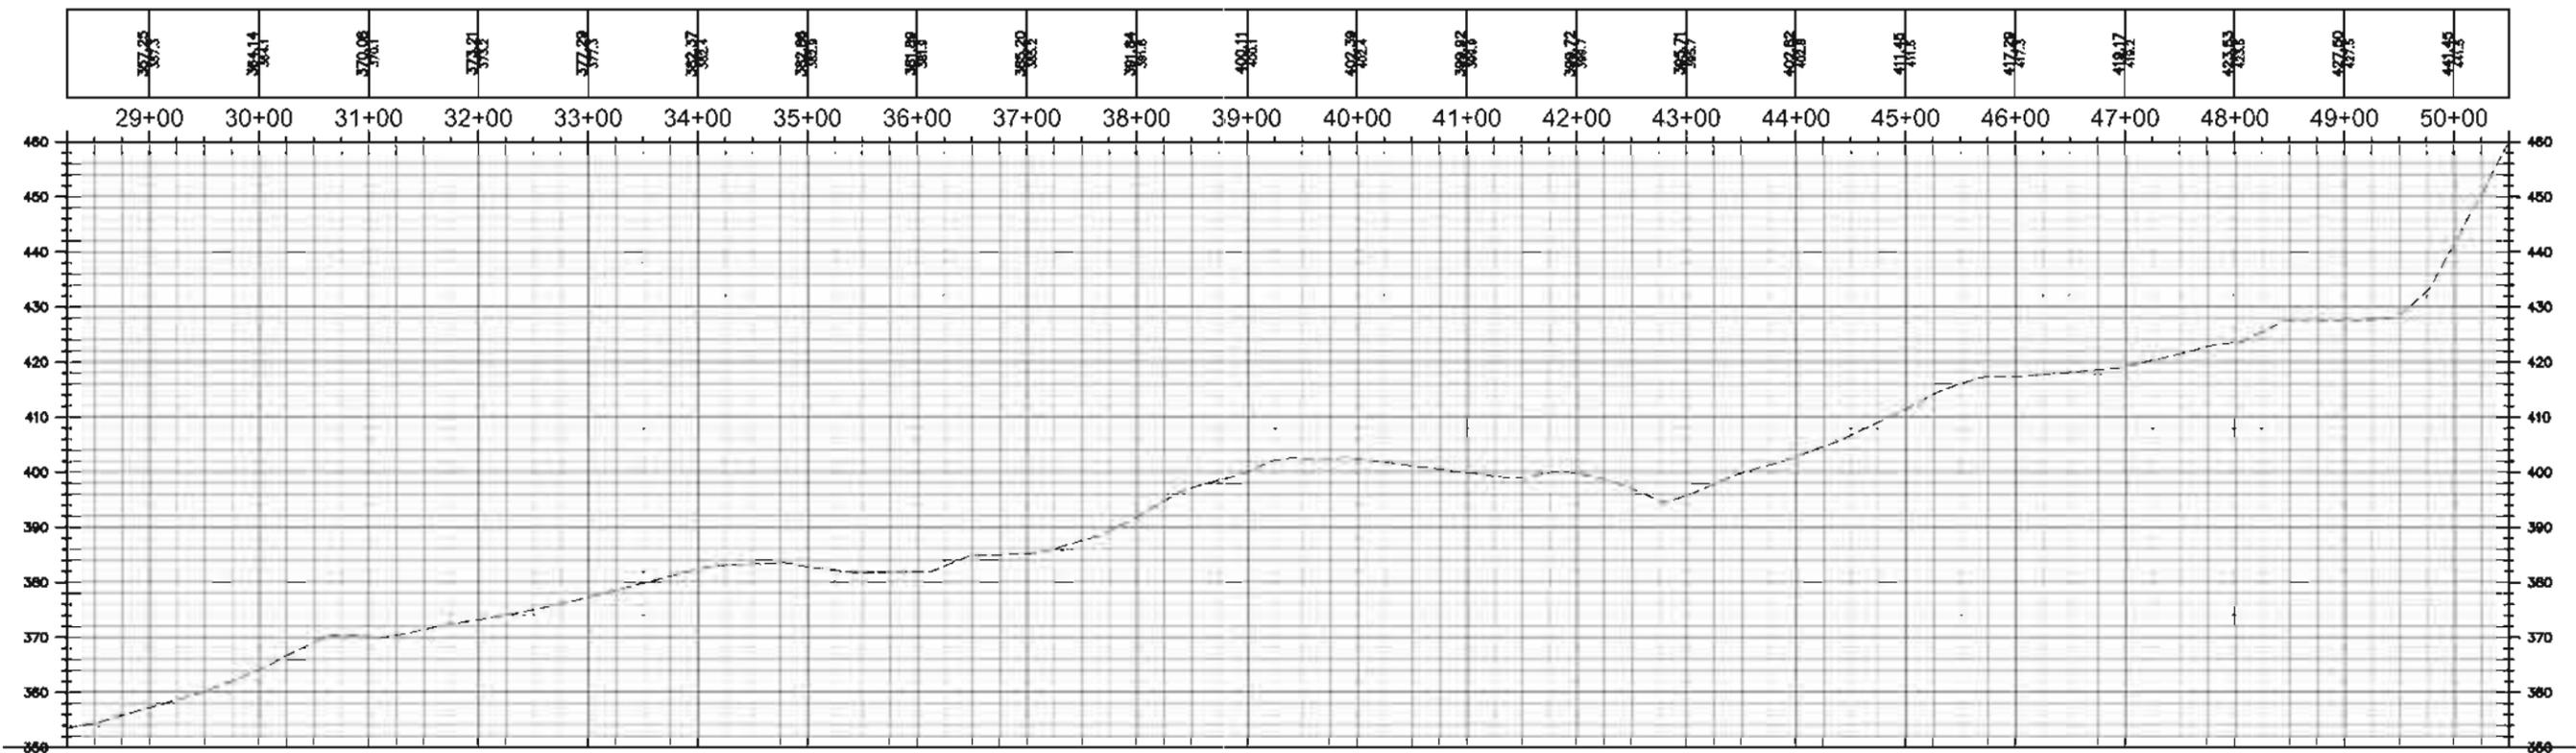
Completed, Approved Plan, Record Drawing Path: S:\gwinthum\romney\middle trail profile.mxd - 6. Fri, May 20 2011 - 1:19:56pm.
