**PRELIMINARY GEOTECHNICAL INVESTIGATION REPORT
VALLEYS EDGE MULTI-USE DEVELOPMENT
DOE MILL/HONEY RUN SPECIAL PLANNING AREA
CHICO, CALIFORNIA**

Updated February 27, 2019

**Subject: Preliminary Geotechnical Investigation Report
Valleys Edge Multi-Use Development
Doe Mill/Honey Run Special Planning Area, Chico, California**

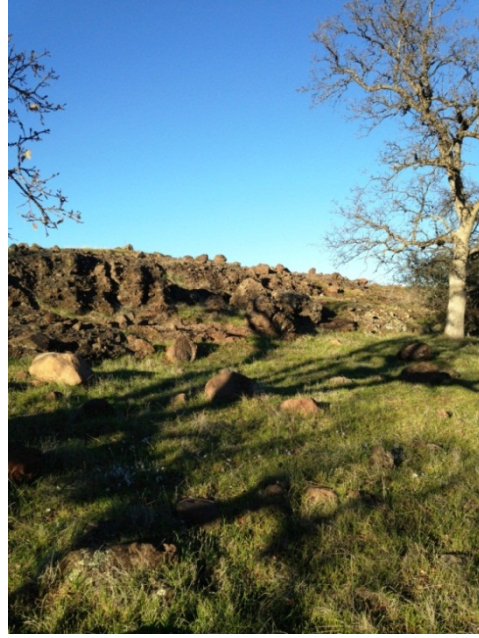
Photo 2: Lahar ledge outcrop at break from gentle to moderate slope. The ledge pictured, located between Sections 115 and 118, is 3- to 4-feet high.

Surface exposures of the lahar are common all over the site, particularly on the treeless mesas and on slopes between the mesas (See Photos 1 and 4 below). Areas where hard lahar is exposed at the surface or beneath a very thin mantle of soil are referred to by the local contractors as “lava cap”. On the aerial photograph base map of Plate 3, larger areas of rock outcrop on slopes are visible as darker brown and gray patches above and/or below tree lines. Rock outcrop as small ledges are also common within the tree lines at the margins of the broad mesas (See Photo 2 below).

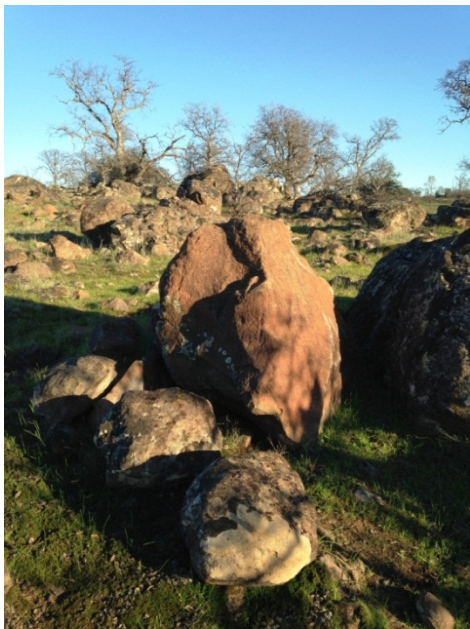
Photo 3: Boulder field at slope break on south side of Section 118. Boulders are up to 7-feet nominal dimension.

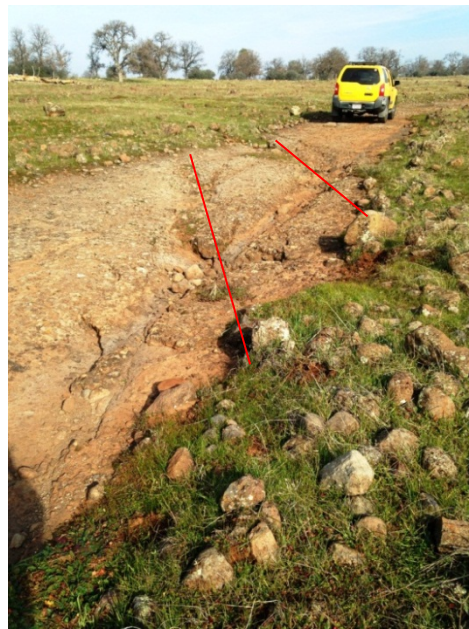
Photo 4: Doe Mill Road at Section 232. Lahar has been exposed by removing 2 to 5 inches of soil. Red lines demark two NNE trending, near vertical fractures within the lahar that are common to the site and vicinity.

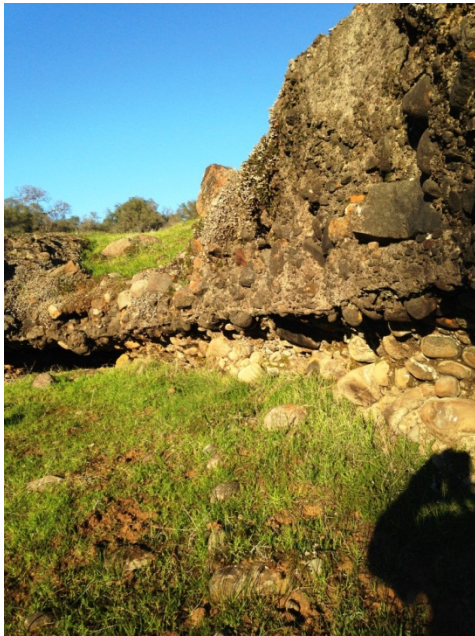
Photo 5: 3 foot thick conglomerate lens beneath 4 foot thick lahar layer at ravine within Section 118. More lahar underlies conglomerate lens, which is of limited lateral extent. Note the rounded cobble in the conglomerate vs the more angular clasts within the lahar.

Thin conglomerate lenses and channel fills are present between lahar units. These were observed in a few areas of the site within eroded stream channels. The observed conglomerate was generally weakly to well-cemented gravel and cobble conglomerate with occasional sandstone layers. Where observed the conglomerate ranged from about 2 to 8 feet in thickness (See Photos 5 and 6 below).

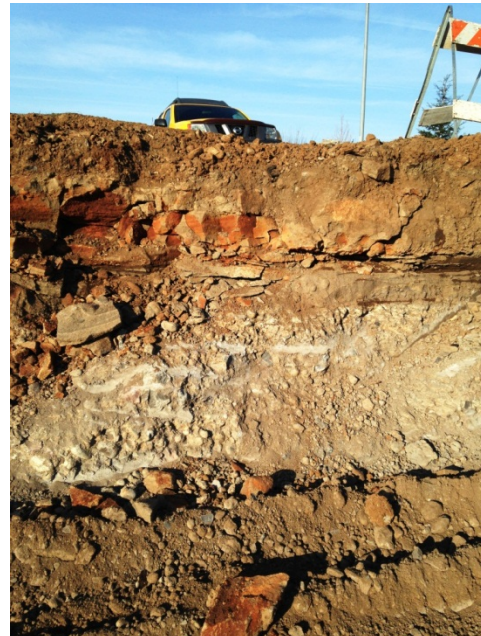
Photo 6: 6 foot thick section of sandstone and conglomerate within storm drain trench exposure at the end the existing paved Doe Mill Road (Section 226). Per the trenching contractor, very hard lahar underlies the conglomerate at the bottom of the photo.

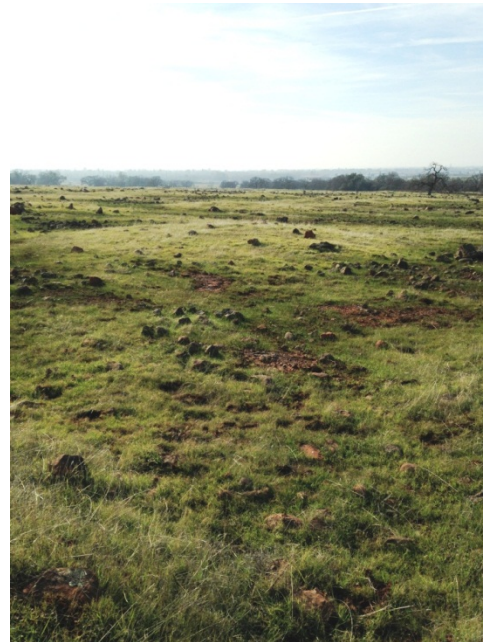
Photo 9: Soil Mounds on gently sloping lava cap terrain at Section 204
